Research Paper NE-647

Photographic Guide of Selected External Defect Indicators and Associated Internal Defects in Sugar Maple

Everette D. Rast
John A. Beaton
David L. Sonderman

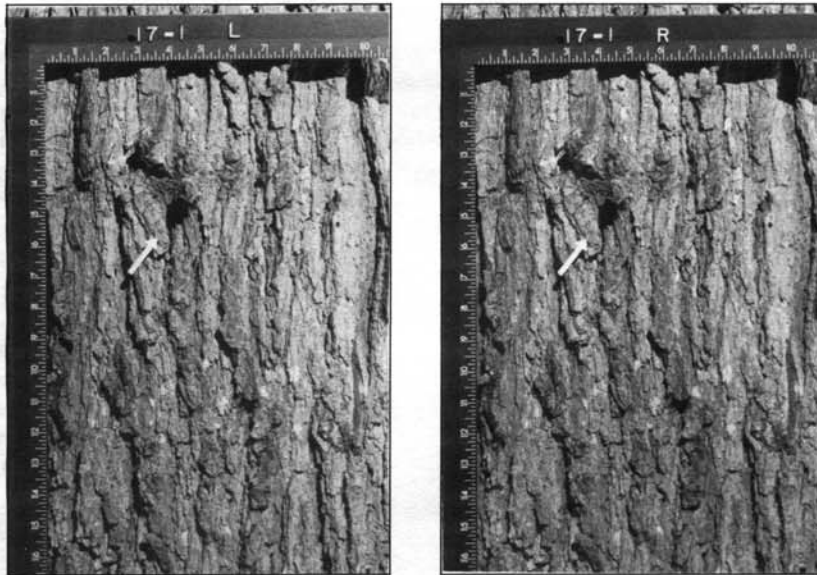
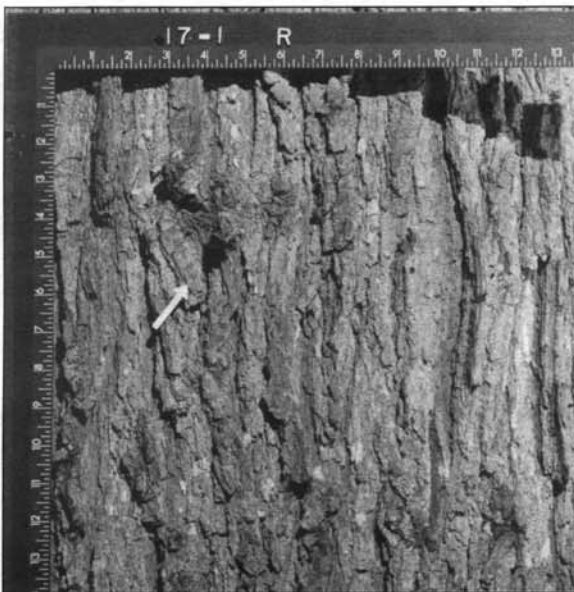
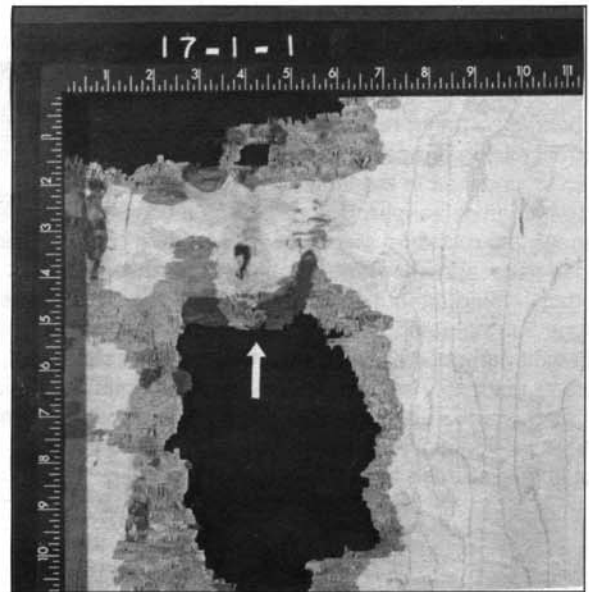
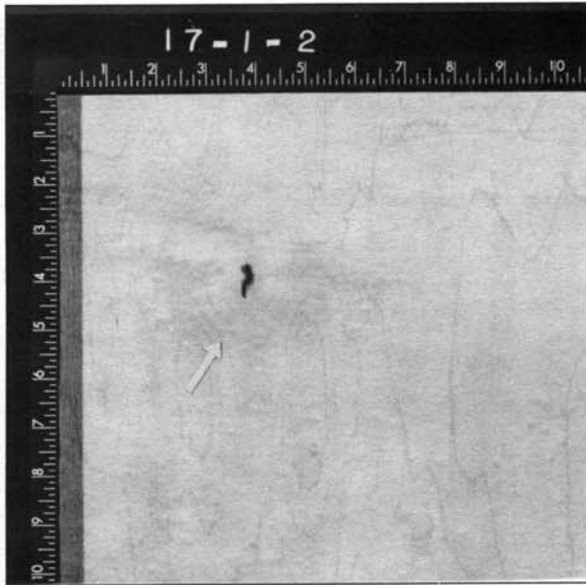
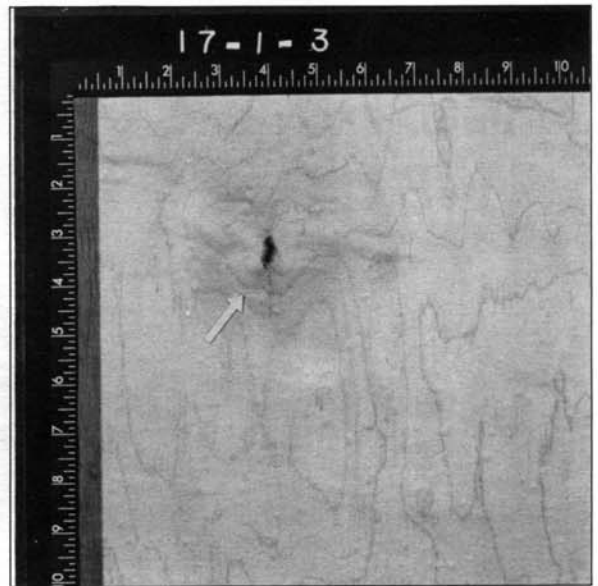
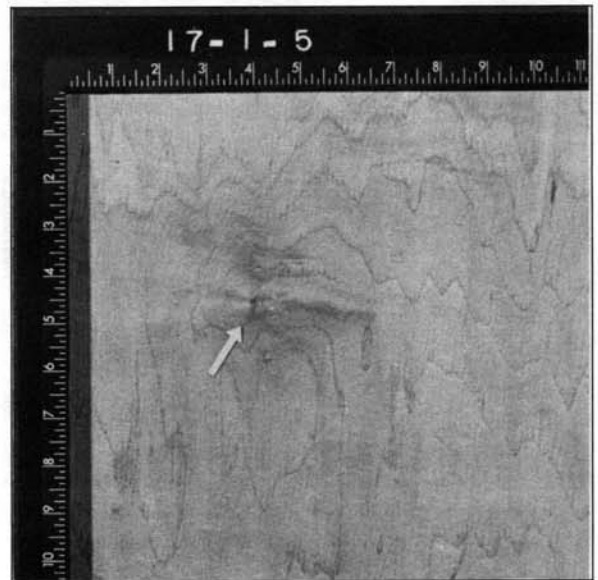
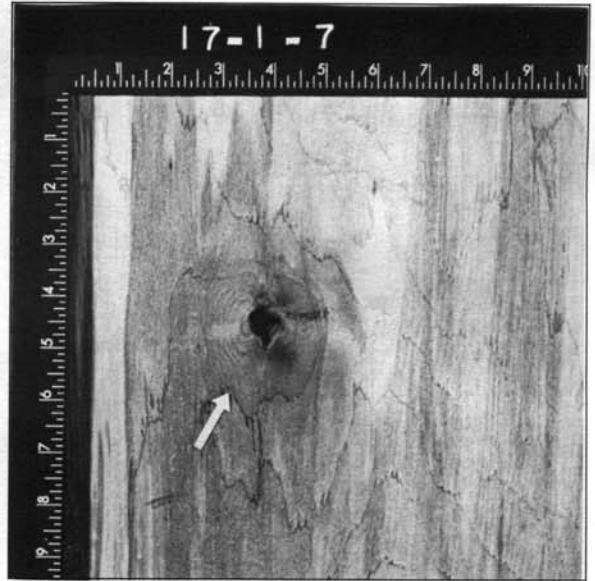
Figure 1.—Suppressed bud and associated internal defects.

Epicormic branches develop from two types of buds: suppressed or dormant buds and adventitious buds (Kormanik and Brown 1969 and Shigo 1986). **Suppressed buds** (Figs. 1 and 2) can persist for many years as a bud trace or they can sprout suddenly after some stimulus such as thinning or damage to the tree. After sprouting, many develop into small limbs that often die. In contrast, bud traces usually continue to form in the cambial zone even after the epicormic limb dies and eventually drops off (Fig. 1), sometimes forming another epicormic limb which may or may not develop. Occasionally the suppressed bud may cease all activity in the cambial zone following its occurrence, showing no evidence of the bud trace (Fig. 2). By contrast, adventitious buds form anew from the cambium, usually following injury to the tree. The defect indicator for both bud types is identified by a slight break in the bark pattern with a small protuberance in the center.

Defect size 1/2 x 1/2 inches
 Log diameter at defect (ib) 22.1 inches
 Round-up thickness 0.5 inch
 Core diameter 5.7 inches
 Defect distance above stump 5.5 feet

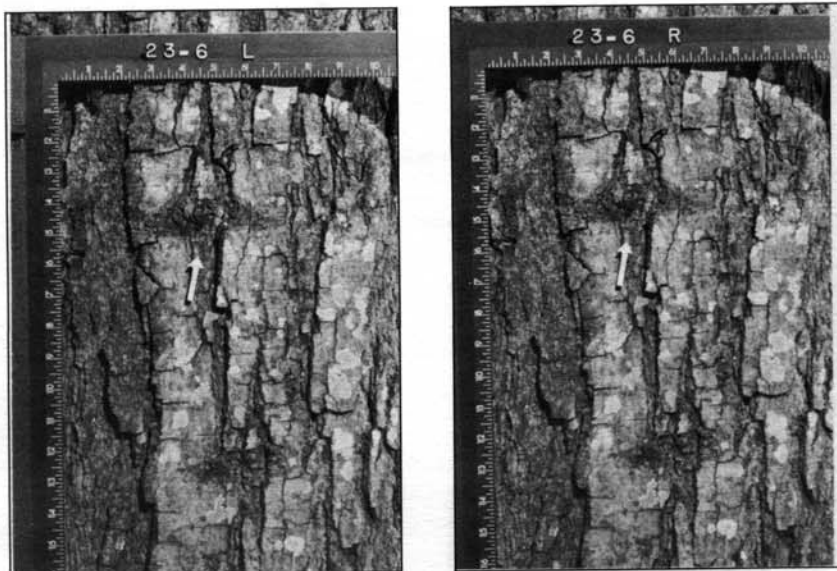
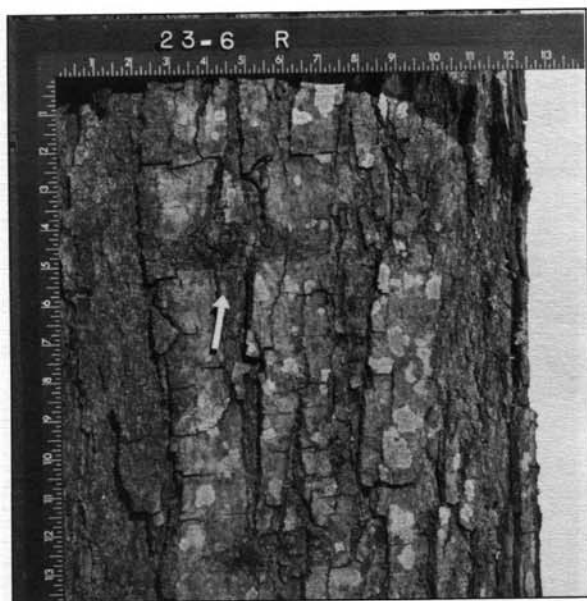
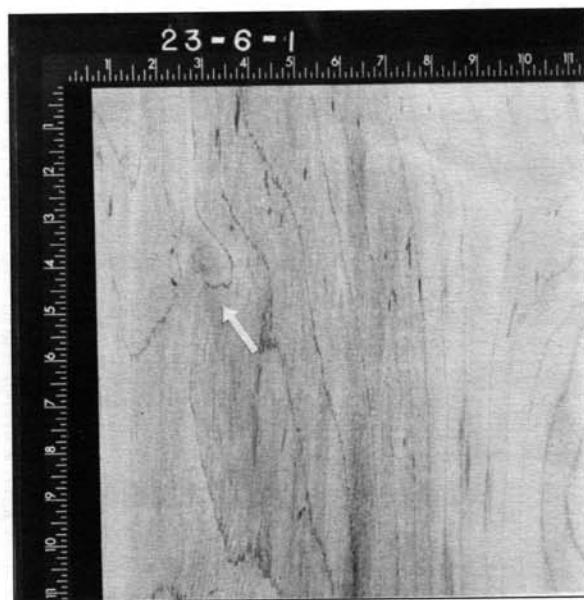
Figure 2.—Suppressed bud and associated internal defects.

Defect size 1/2 x 1/2 inches
 Log diameter at defect (ib) 16.2 inches
 Round-up thickness 0.3 inch
 Core diameter 5.8 inches
 Defect distance above stump 13.5 feet

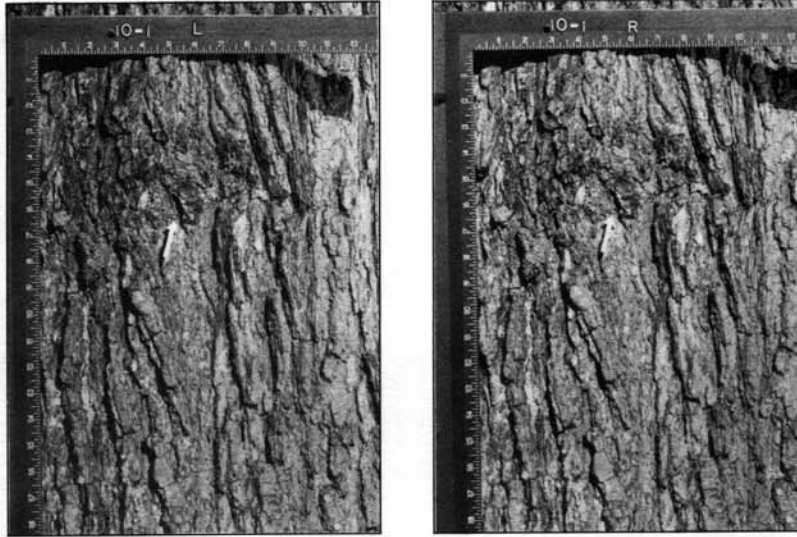
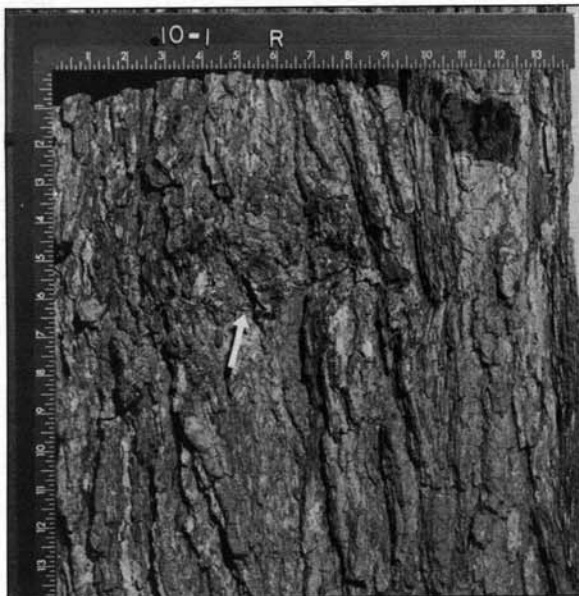
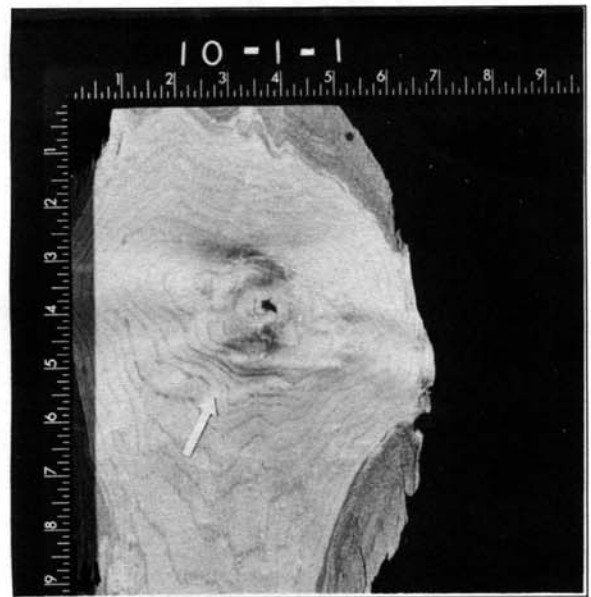
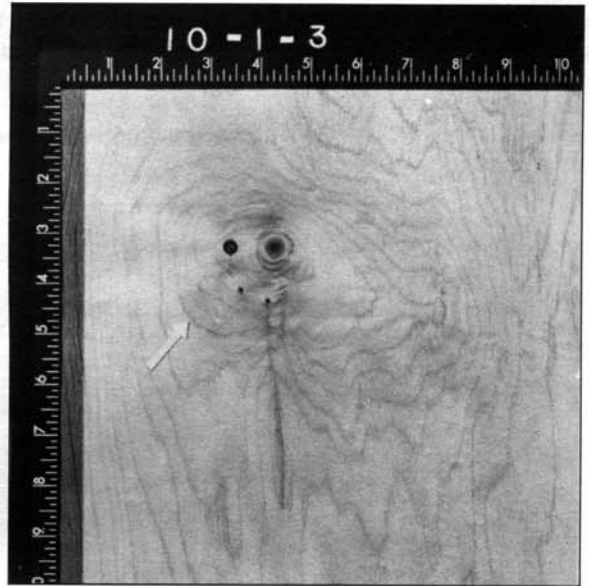
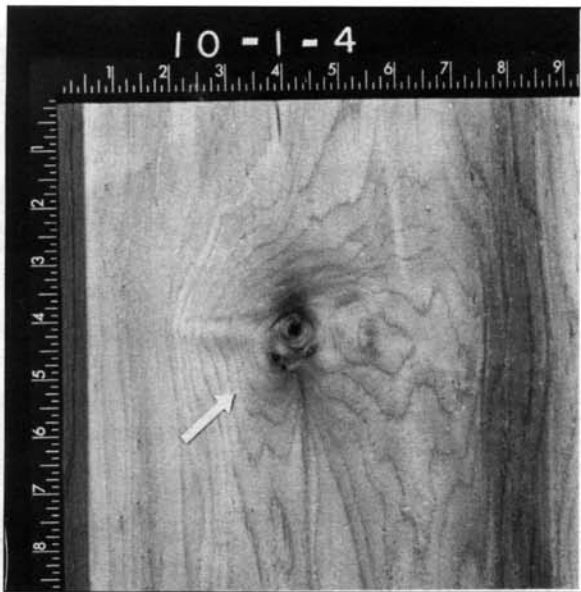
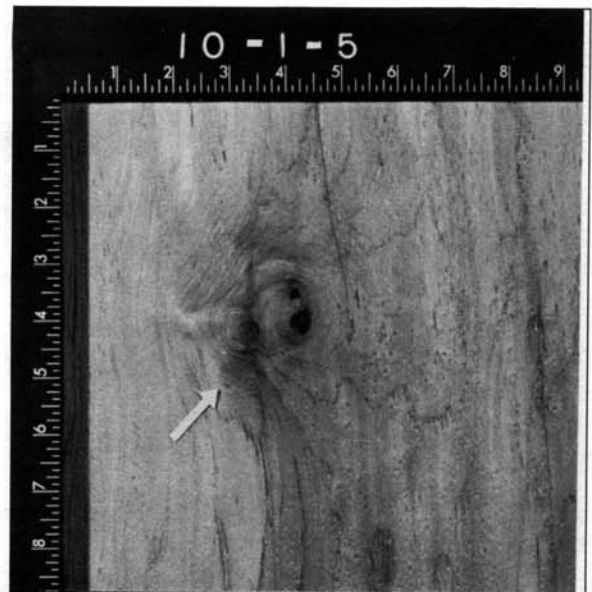
Figure 3.—Suppressed bud cluster and associated internal defects.

As its name implies, a **suppressed bud cluster** is a group of suppressed buds (3 to 20) tightly clustered in a small area, normally less than 2 by 2 inches in size. Usually, there is evidence of concentric rings around the defect indicator.

Figure 3 shows a faint evidence of the concentric rings around the defect indicator and the presence of several individual buds. Also, several adventitious knots are visible in the defect photos.

Defect size	1½ × 1½ inches
Log diameter at defect (ib)	18.1 inches
Round-up thickness	0.0 inch
Core diameter	5.9 inches
Defect distance above stump	5.5 feet

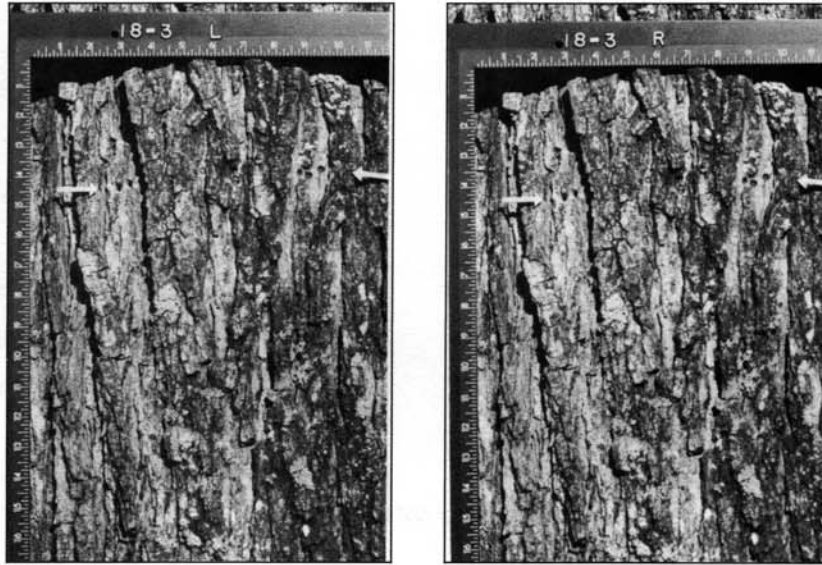
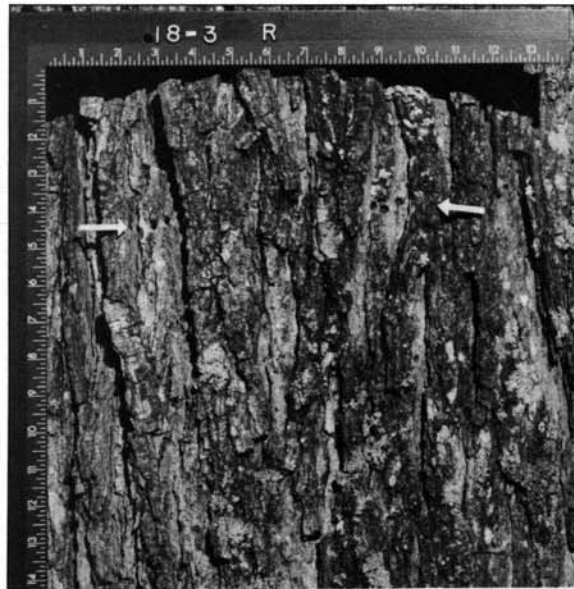
Figure 4.—Open bird peck.

Figure 4 shows primarily **open bird peck** that is not

Defect size	1 × 8 inches
Log diameter at defect (ib)	20.3 inches
Round-up thickness	0.2 inch
Core diameter	5.8 inches
Defect distance above stump	10.0 feet

occluded (two next to the left arrow and one in the center of the photo) and, therefore, can be disregarded. However, careful examination of the photograph reveals several occluded bird pecks (between the two arrows). No photos of veneer defects were taken as the only indication of defects in the wood was these occluded bird pecks.

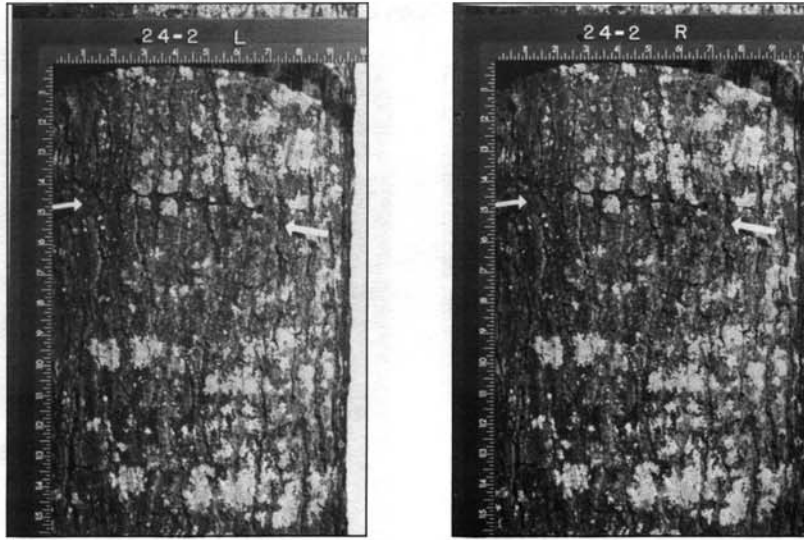
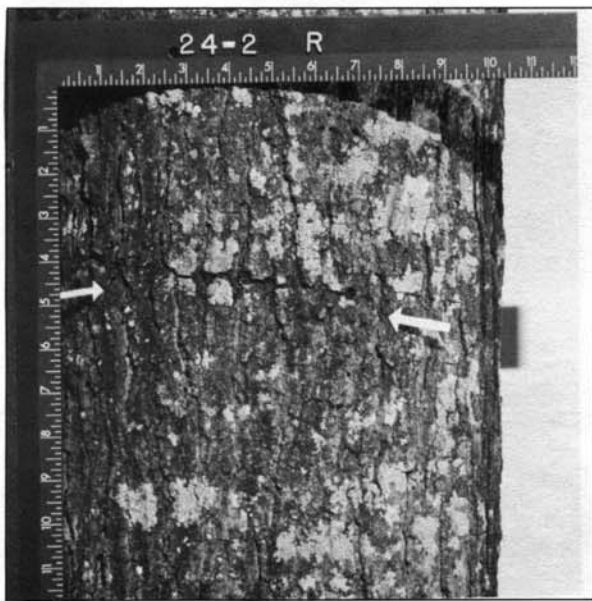
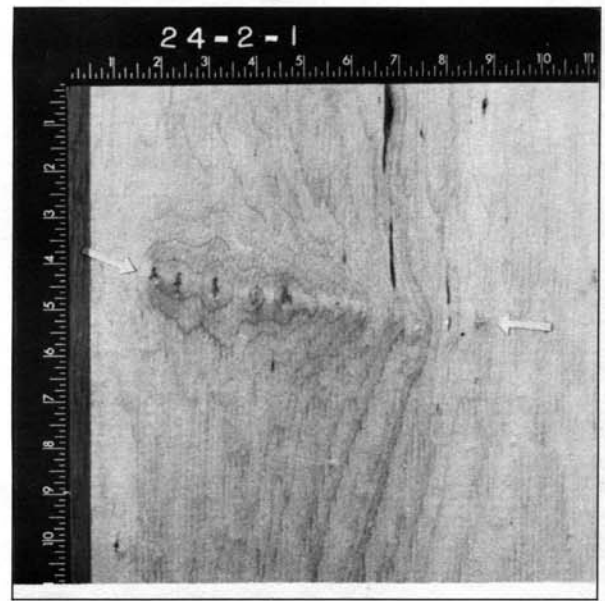
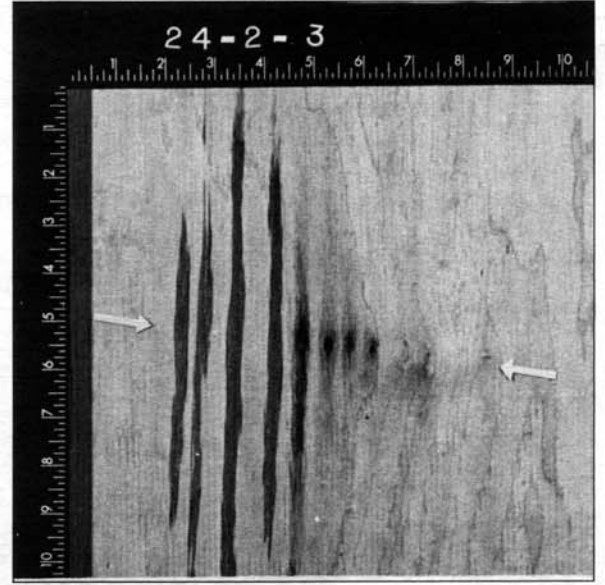
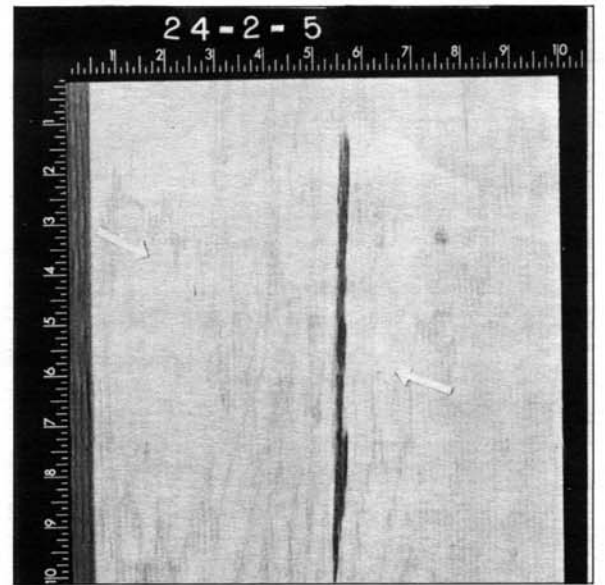
Figure 5.—Occluded (closed) bird peck and associated internal defects.

By contrast, in looking at the **occluded bird peck** in Figure 5, one can observe clearly the callus material in the pecked holes and the defects in the underlying wood. The accompanying stain is quite normal with occluded bird peck due to the easy entry of moisture and pathogens. Severe bird peck can lead to a separation of the wood along the rings.

Defect size	1 x 9 inches
Log diameter at defect (ib).....	11.7 inches
Round-up thickness	0.1 inch
Core diameter	5.6 inches
Defect distance above stump	5.0 feet

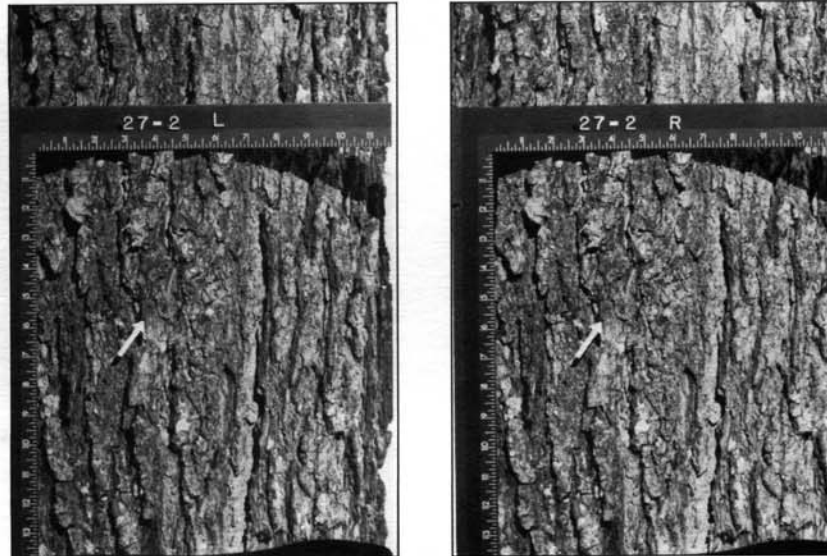
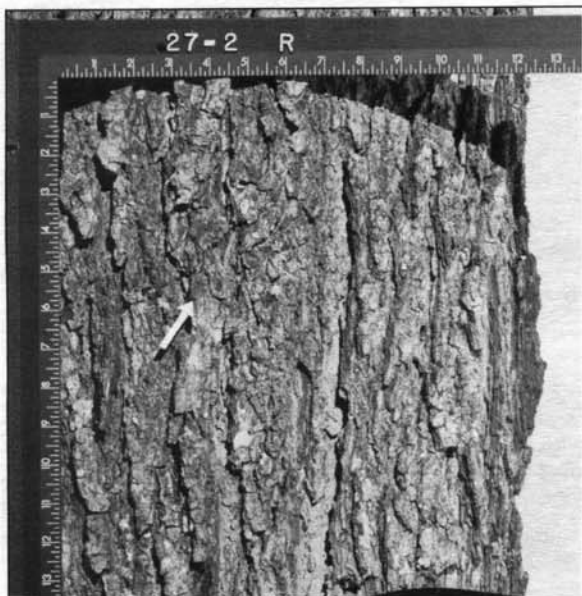
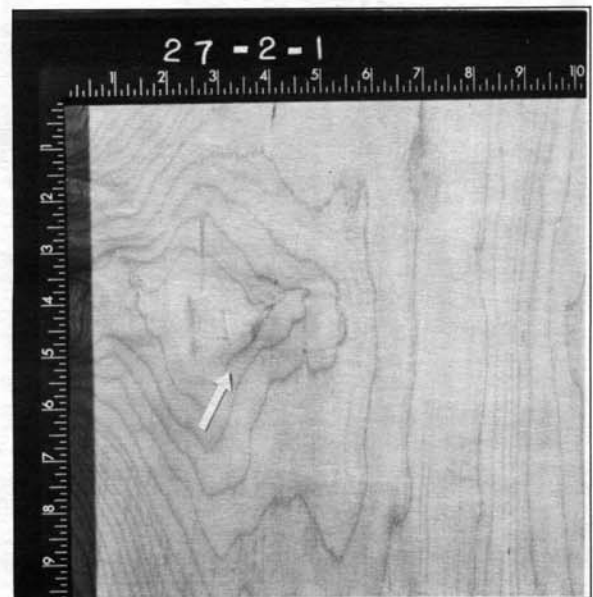
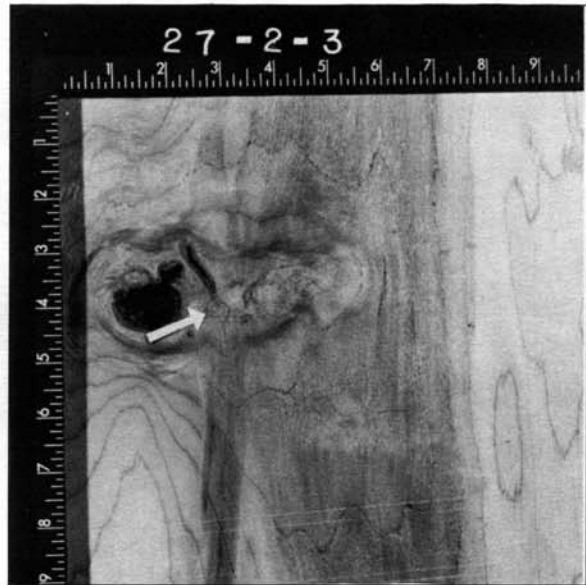
Figure 6.—Light bark distortion and associated internal defects.

Bark distortions usually indicate an overgrown knot, and because of age they have no height measurement (flush with the normal contour of the bark). They are classified as light, medium, or heavy. A **light bark distortion** (Fig. 6)

shows a slight amount of curvature in the surrounding bark plates, and the bark pattern varies only slightly from normal. Because of these features, light bark distortions are inconspicuous and often overlooked. **Medium bark distortions** (Fig. 7) show more of the concentric circles, but they are broken in several areas by flat bark plates or the

Defect size	2 x 2 inches
Log diameter at defect (ib)	16.4 inches
Round-up thickness	0.0 inch
Core diameter	6.2 inches
Defect distance above stump	7.0 feet

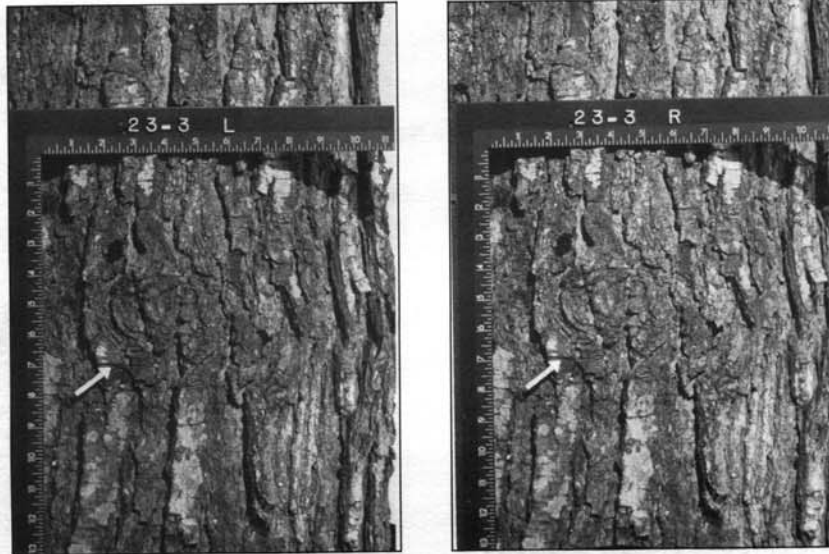
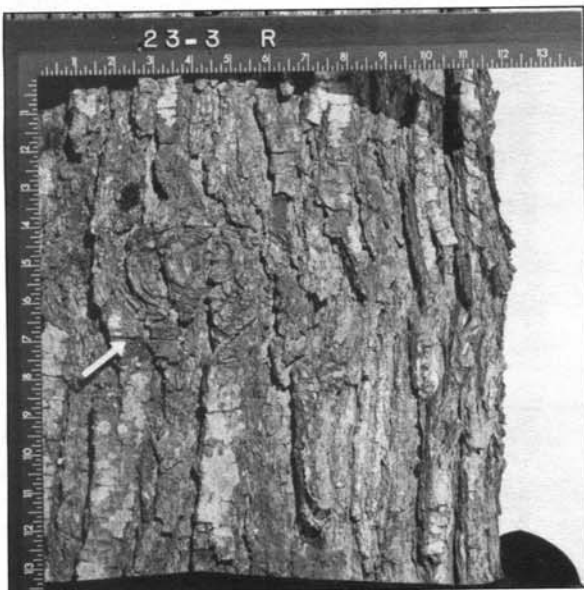
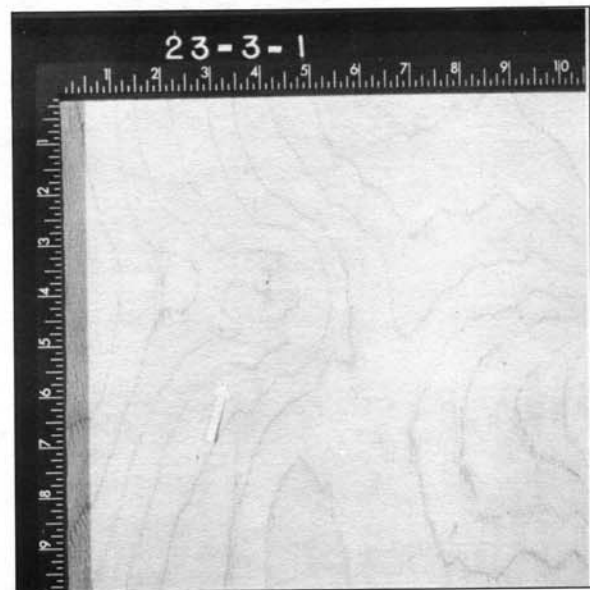
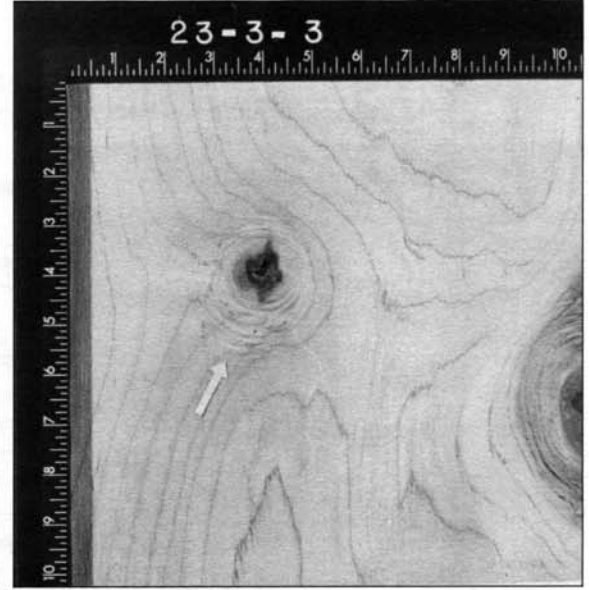
Figure 7.—Medium bark distortion and associated internal defects.

Defect size 3 x 3 inches
 Log diameter at defect (ib) 15.8 inches
 Round-up thickness 0.3 inch
 Core diameter 5.8 inches
 Defect distance above stump 11.5 feet

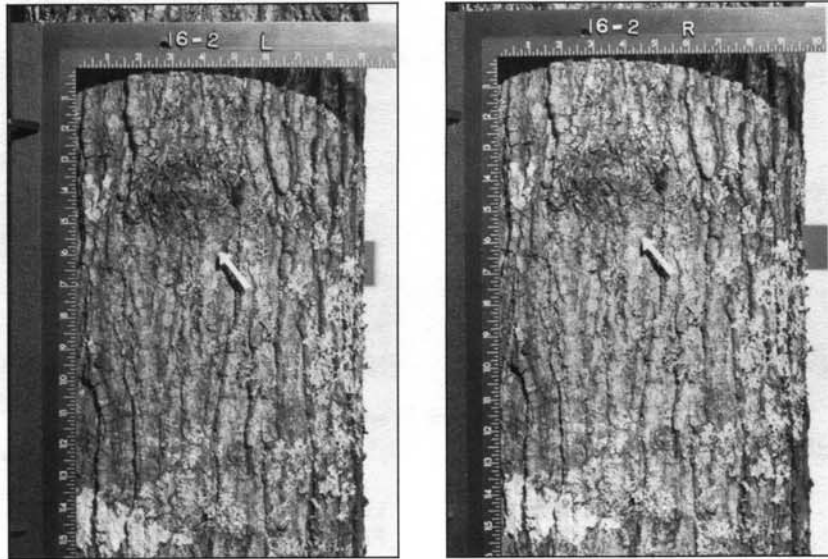
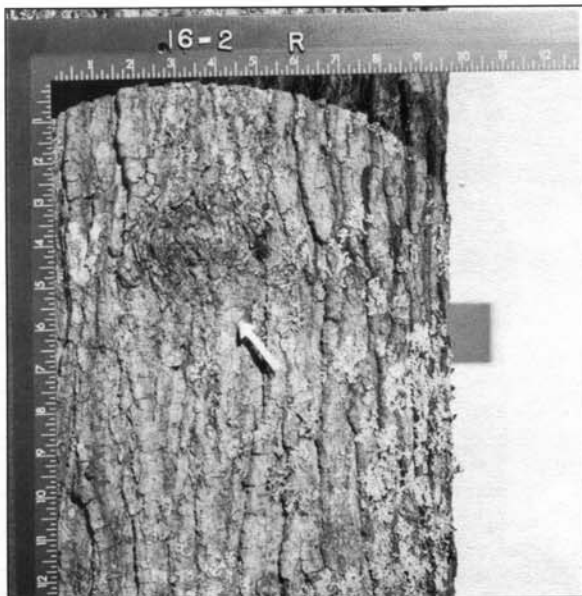
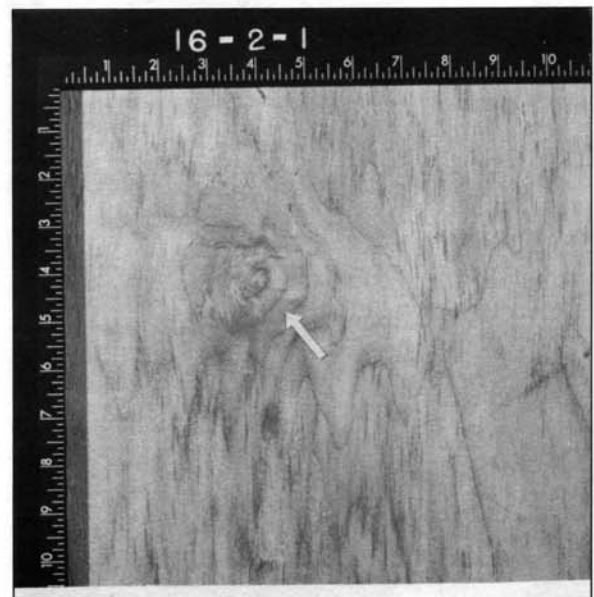
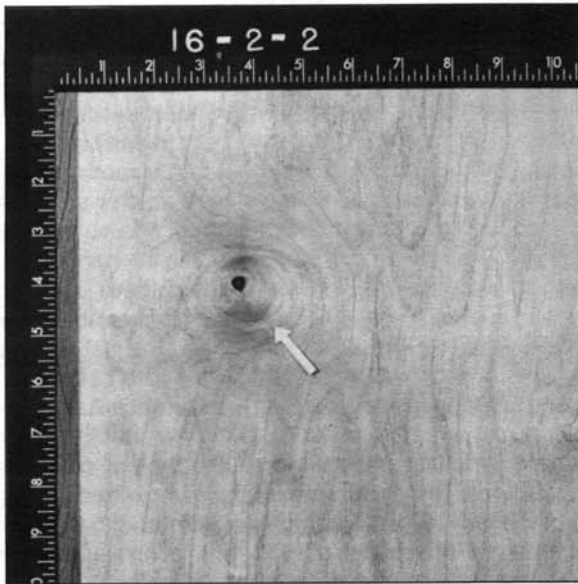
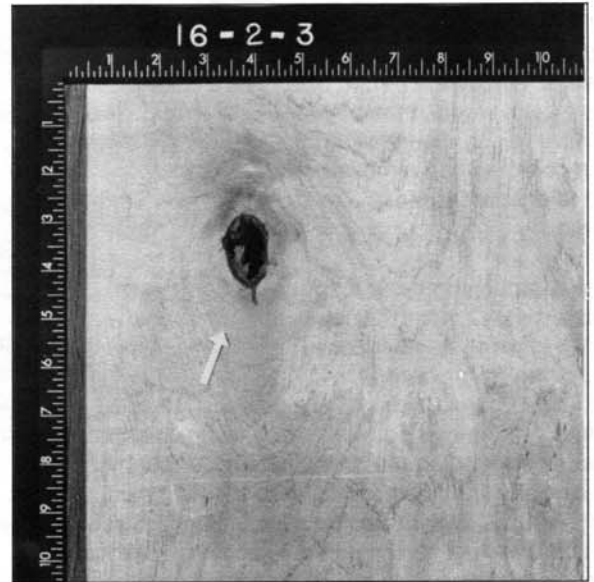
Figure 8.—Heavy bark distortion and associated internal defects.

regular bark pattern running lengthwise through the defect indicator. Also present can be moderate to well-defined breaks in the bark pattern running radially from the outer edges to the center of the defect indicator. **Heavy bark distortions** (Fig. 8) are identified by the characteristic

pattern of concentric circles encompassing the defect indicator and "pucker-like" appearance of the center.

Defect size 2 x 2 inches
 Log diameter at defect (ib) 11.5 inches
 Round-up thickness 0.0 inch
 Core diameter 5.6 inches
 Defect distance above stump 19.0 feet

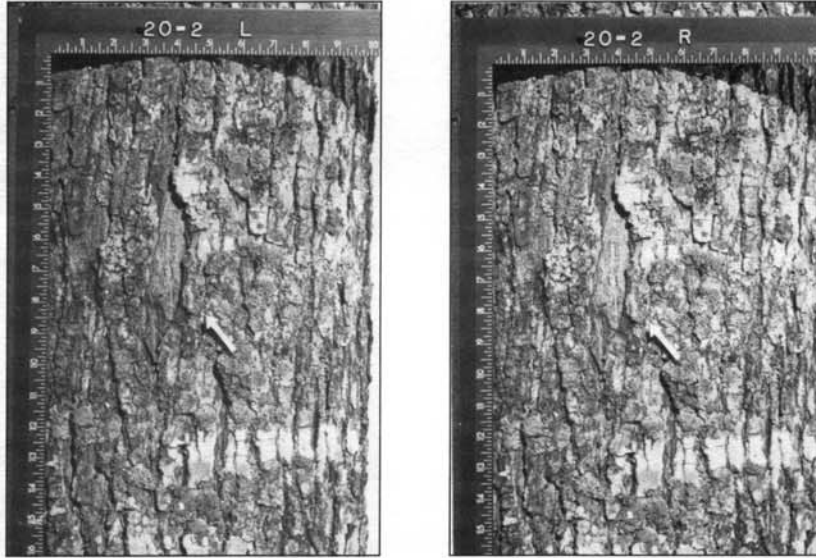
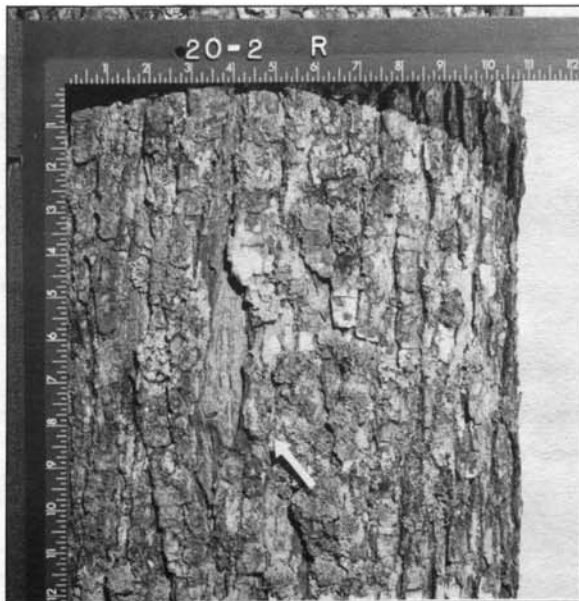
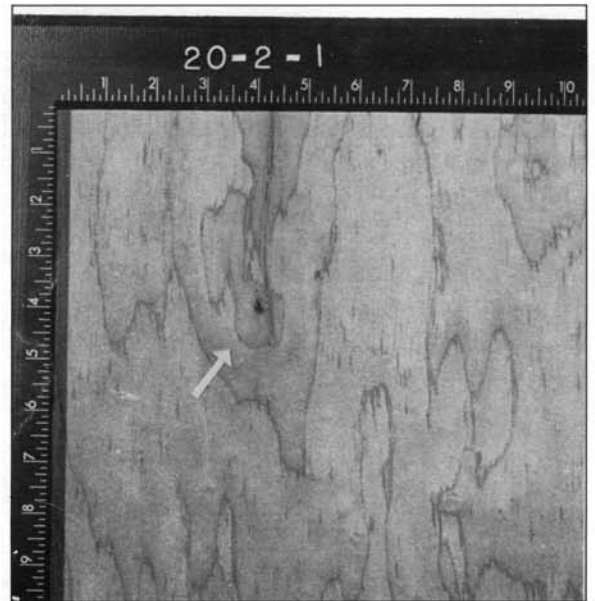
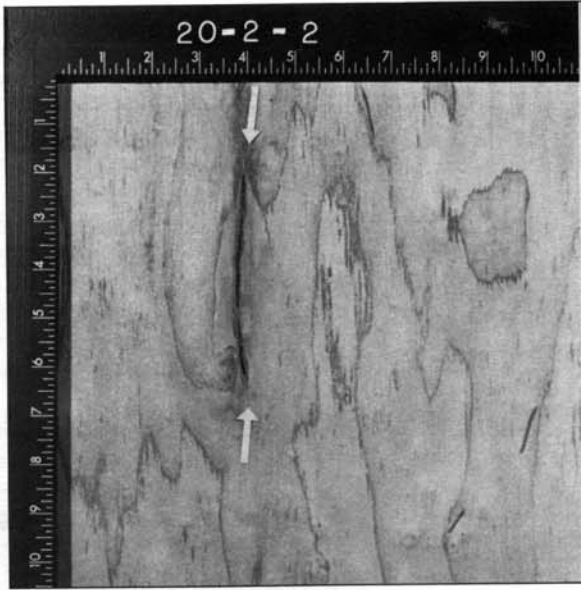
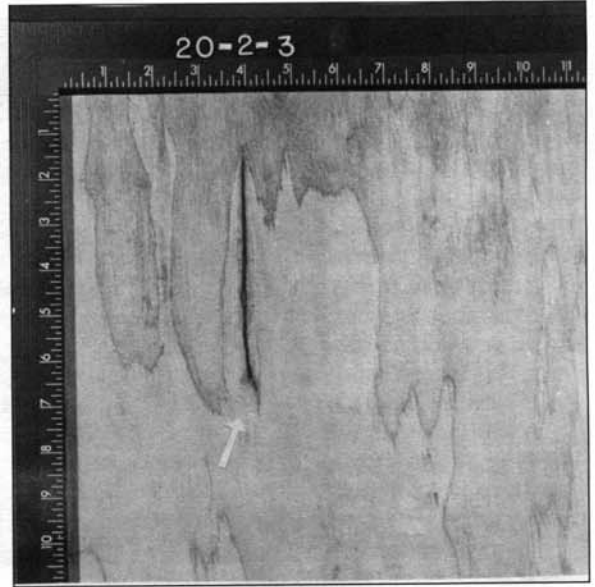
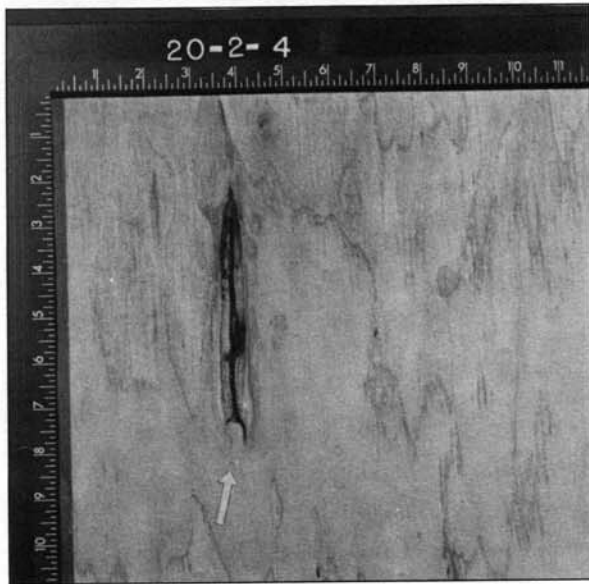
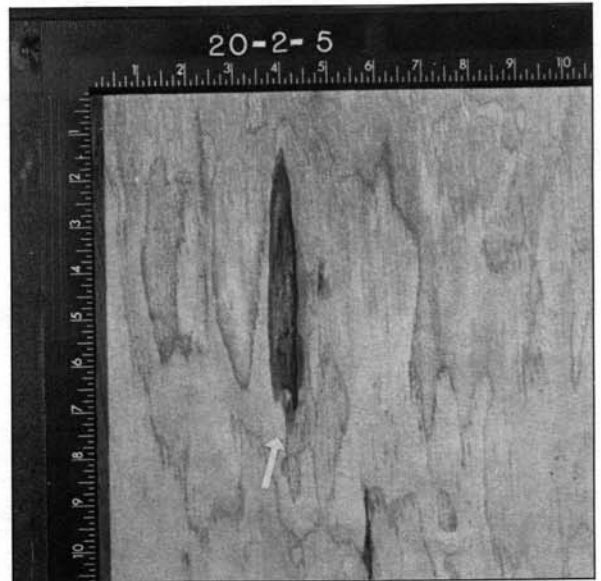
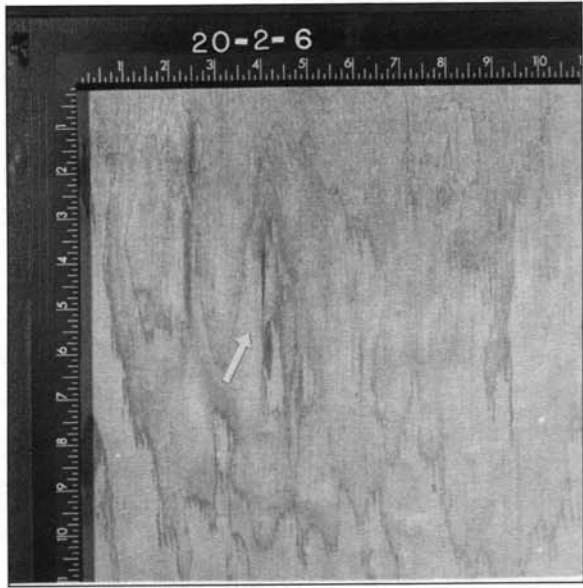
Figure 9.—Sound wound (new) and associated internal defects.

The defect in Figure 9, a **sound wound (new)**, probably was a clean, smooth removal of the bark and some wood on a fast-growing tree because the first and last evidence of the defect in the veneer is contained within eight-tenths of an inch. Figure 10 shows a **sound wound (old)**. The primary difference between these wounds is that the callus tissue surrounding the “new” wound is rough or corky, can have many lines perpendicular to the long axis, and has only a slight ridge or pucker surrounding the seam running lengthwise through the defect indicator. Even the lengthwise seam may be visible only in certain areas. The bark plates surrounding the defect indicator usually are rough and jagged. By contrast, the callus tissue of the “old” wound has a “washed out” or more natural bark appearance, a smooth or nearly smooth surface, and more of a bark-like fissure running lengthwise through its center. The bark plates surrounding the defect indicator of the old

Defect size 5 × 1 inches
 Log diameter at defect (ib) 13.9 inches
 Round-up thickness 0.4 inch
 Core diameter 5.7 inches
 Defect distance above stump 7.0 feet

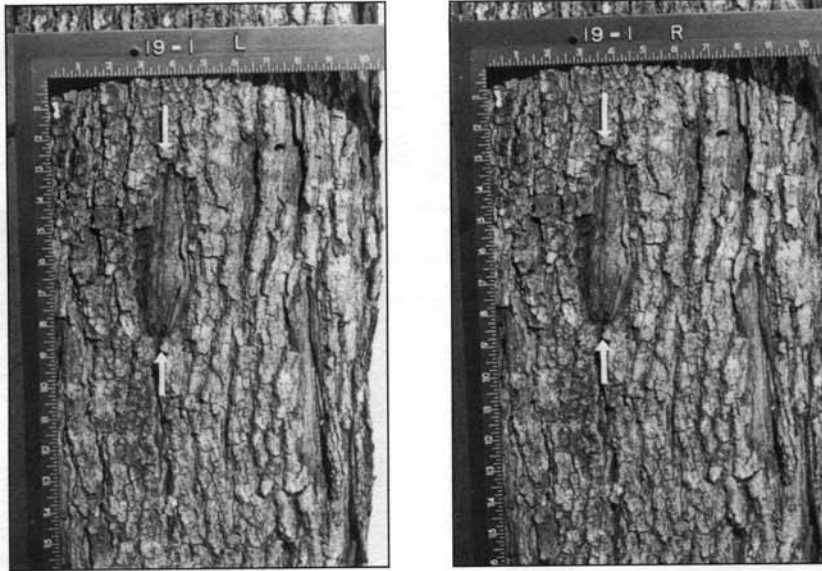
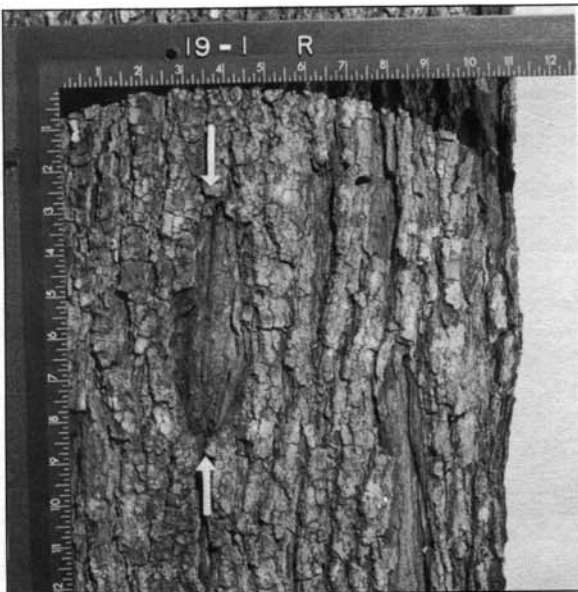
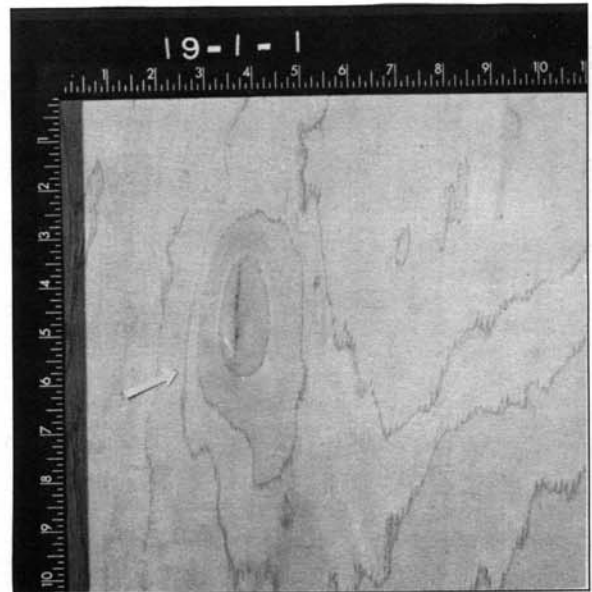
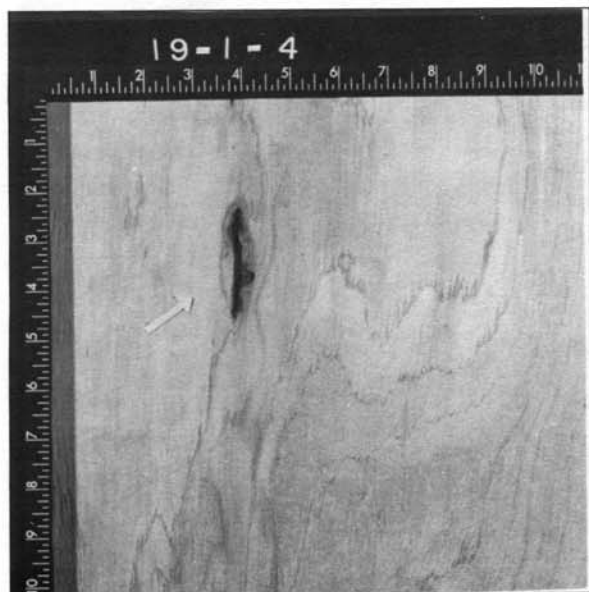
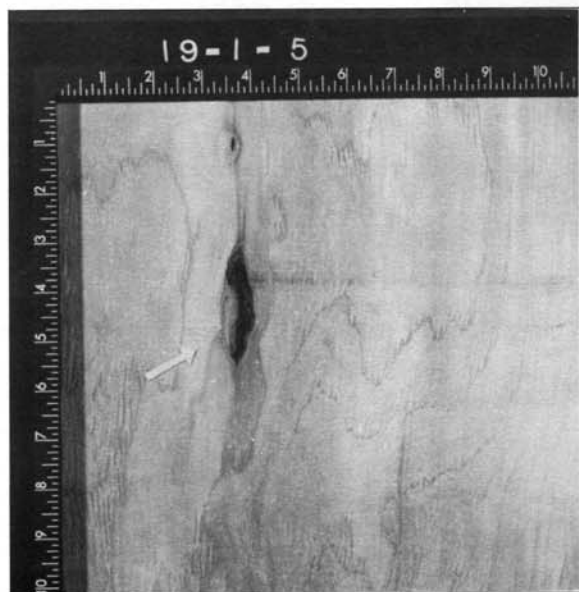
Figure 10.—Sound wound (old) and associated internal defects.

wound are more rounded and smooth.

Defect size 6 × 1 inches
 Log diameter at defect (ib) 14.9 inches
 Round-up thickness 0.5 inch
 Core diameter 5.8 inches
 Defect distance above stump 3.5 feet

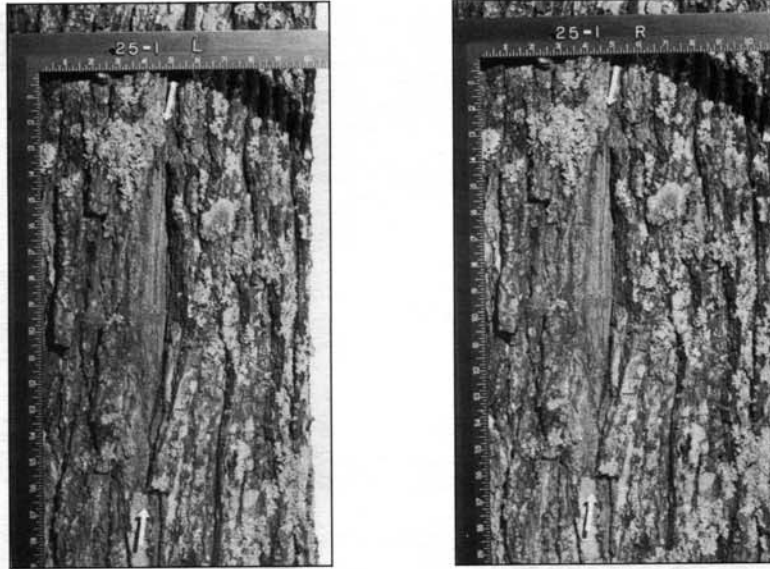
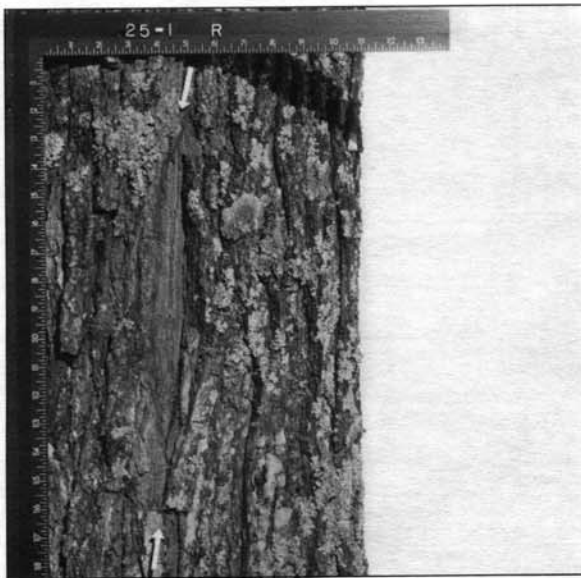
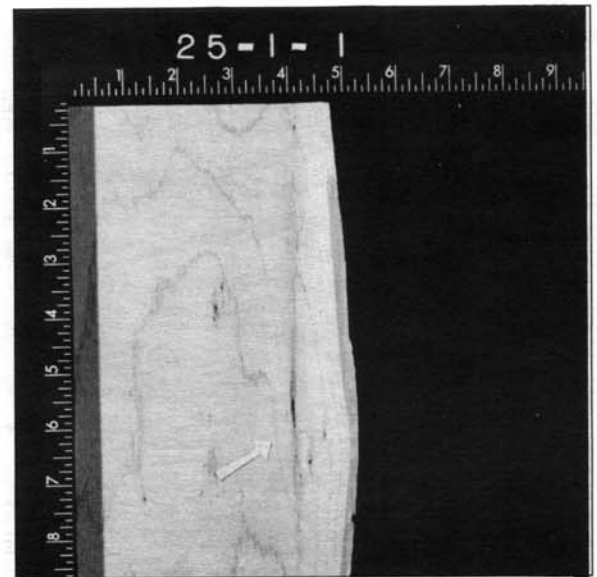
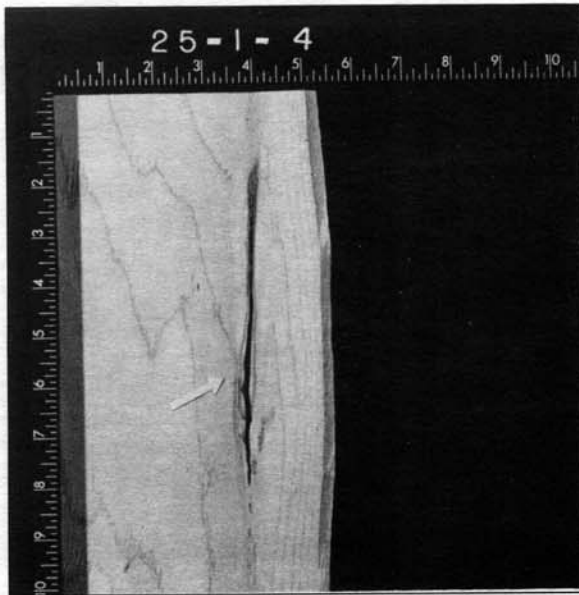
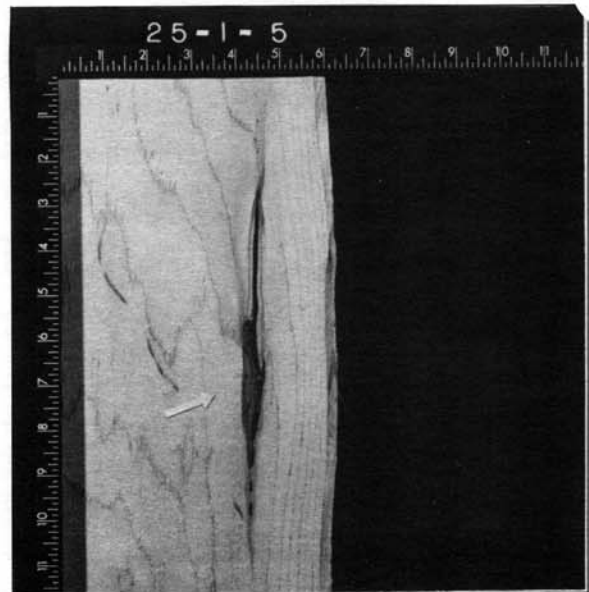
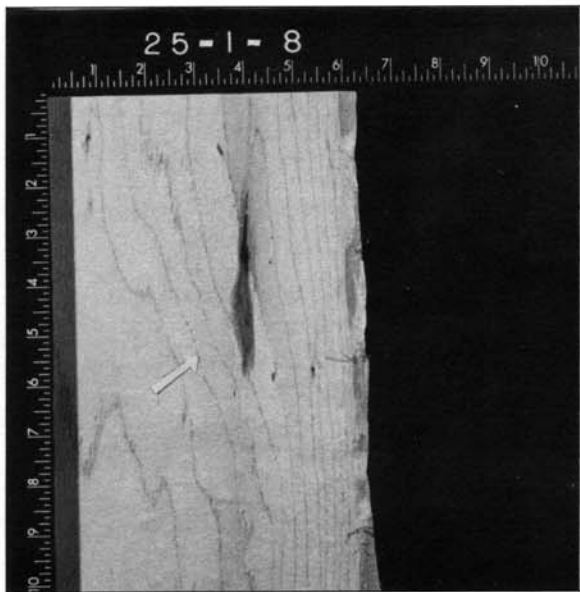
Figure 11.—Sound wound and associated internal defects. (Early spring felling damage)

An uncommon wound encountered during this study is that caused by the felling of one tree against another during the period of active cambial growth (W.C. Shortle, USDA Forest Service, pers. comm. 1989). Trees are most susceptible to wounding from an object hitting the bark in early spring. The damage we noted ranged from 3 or 4 wounds to 25 wounds per tree, and these always were on only one side of the tree stem. They ranged in height from 5 to 40 feet above the ground and ranged in length from 3 to 12 inches. Figures 11 and 12 are typical examples of these defects. The first evidence of each of these defects was about one-half inch below the surface of the log and the last evidence of the defect in the wood generally was 1 inch below the surface of the log. Personnel with the Florence Ranger District confirmed that the felling in this area took place in 1984 during the last week of March and the first couple of weeks of April. The growth rate of the sample trees averaged about one-quarter inch per year and the study trees were cut in September 1987, which correlates with the fact that the deepest defects are approximately 1 inch below the surface of the log. Defects of this nature will be devastating to the quality of those trees affected, particularly during a selection cutting in which the remaining trees are in the intermediate and mature sawtimber size classes.

Defect size 10 x 1 inches
 Log diameter at defect (ib)..... 14.9 inches
 Round-up thickness 0.0 inch
 Core diameter 5.9 inches
 Defect distance above stump 14.0 feet
