Research Paper NE-647

Photographic Guide of Selected External Defect Indicators and Associated Internal Defects in Sugar Maple

Everette D. Rast
John A. Beaton
David L. Sonderman

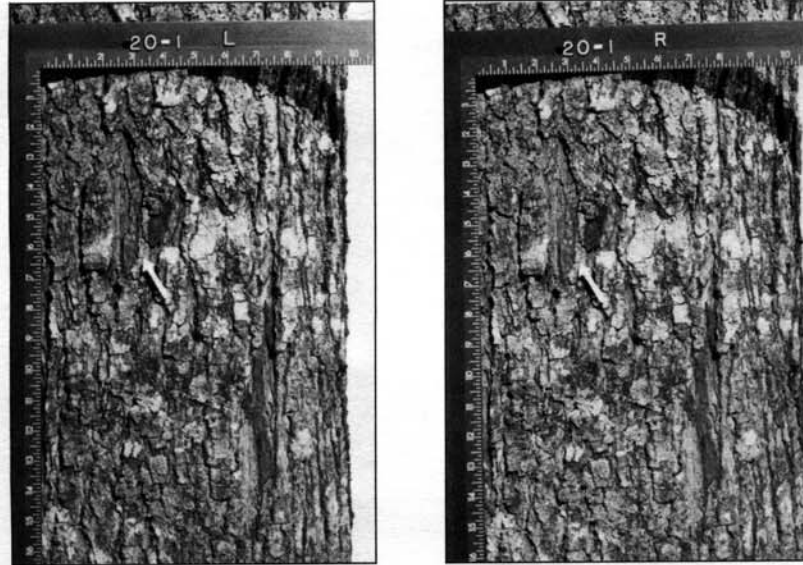
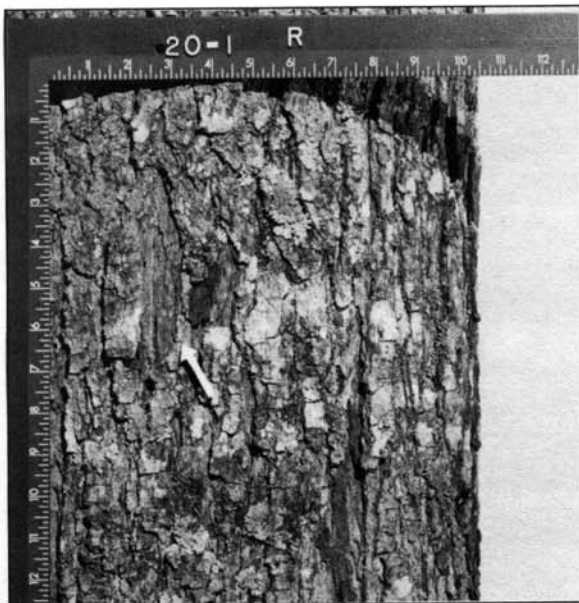
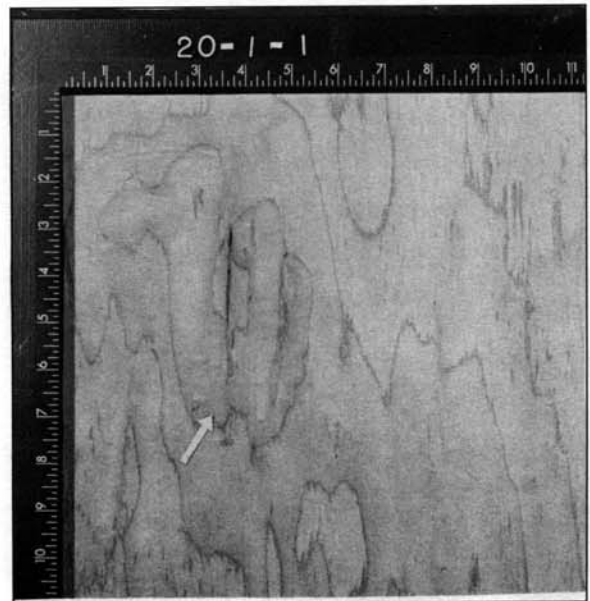
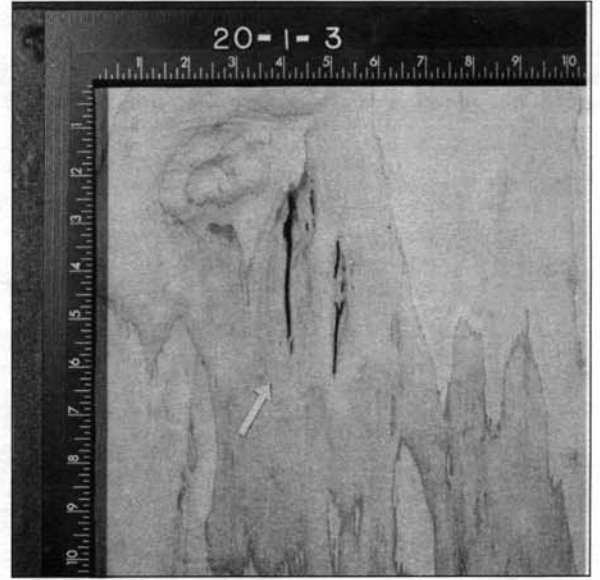
Figure 12.—Sound wound and associated internal defects. (Early spring felling damage)

An uncommon wound encountered during this study is that caused by the felling of one tree against another during the period of active cambial growth (W.C. Shortle, USDA Forest Service, pers. comm. 1989). Trees are most susceptible to wounding from an object hitting the bark in early spring. The damage we noted ranged from 3 or 4 wounds to 25 wounds per tree, and these always were on only one side of the tree stem. They ranged in height from 5 to 40 feet above the ground and ranged in length from 3 to 12 inches. Figures 11 and 12 are typical examples of these defects. The first evidence of each of these defects was about one-half inch below the surface of the log and the last evidence of the defect in the wood generally was 1 inch below the surface of the log. Personnel with the Florence Ranger District confirmed that the felling in this area took place in 1984 during the last week of March and the first couple of weeks of April. The growth rate of the sample trees averaged about one-quarter inch per year and the study trees were cut in September 1987, which correlates with the fact that the deepest defects are approximately 1 inch below the surface of the log. Defects of this nature will be devastating to the quality of those trees affected, particularly during a selection cutting in which the remaining trees are in the intermediate and mature sawtimber size classes.

Defect size 5 x 1 inches
 Log diameter at defect (ib) 14.2 inches
 Round-up thickness 0.0 inch
 Core diameter 5.7 inches
 Defect distance above stump 7.5 feet

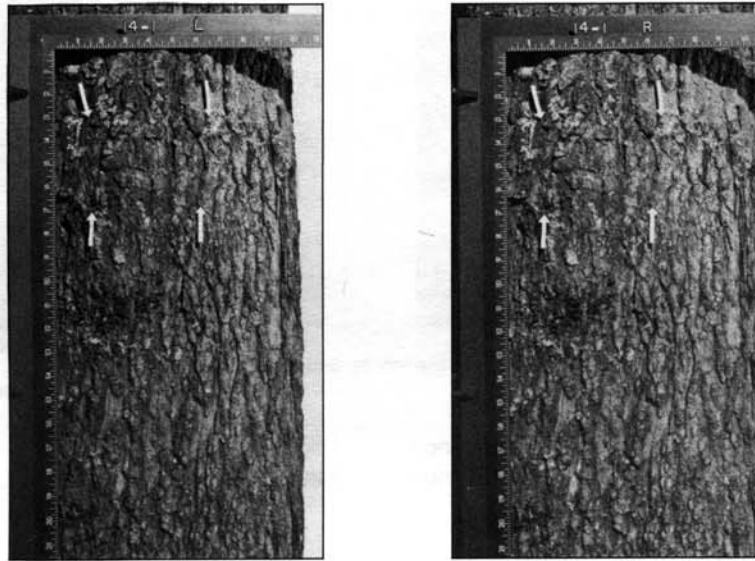
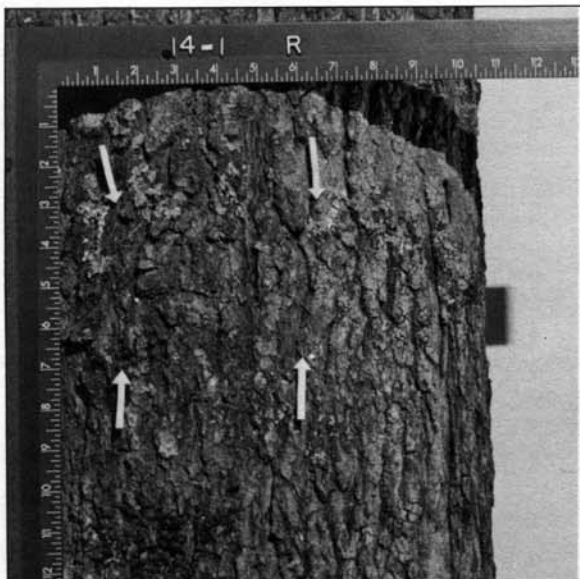
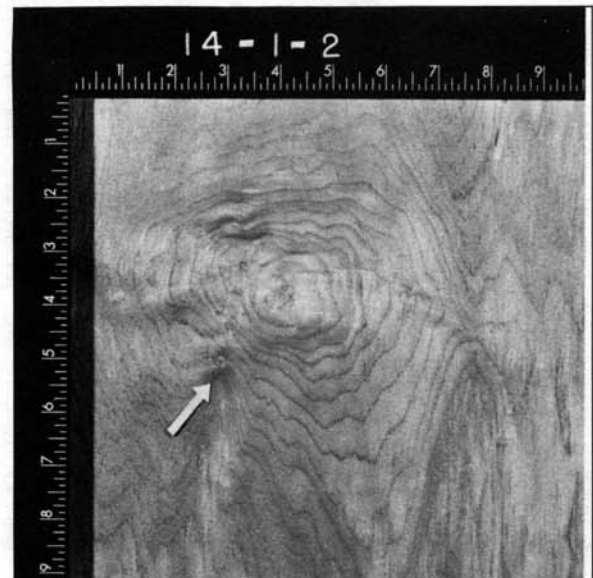
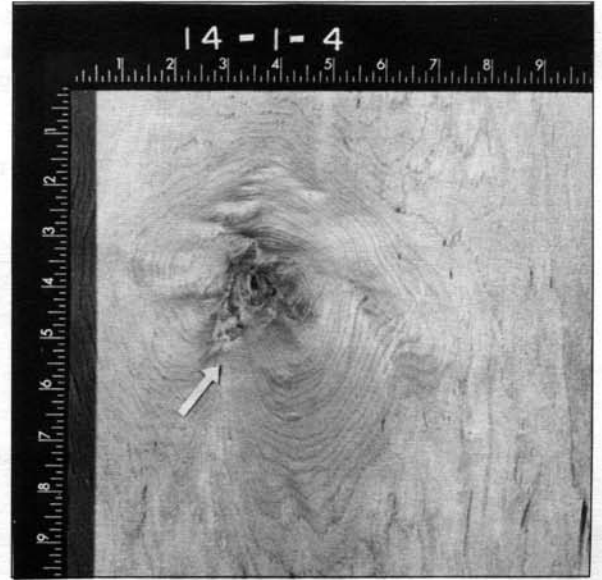
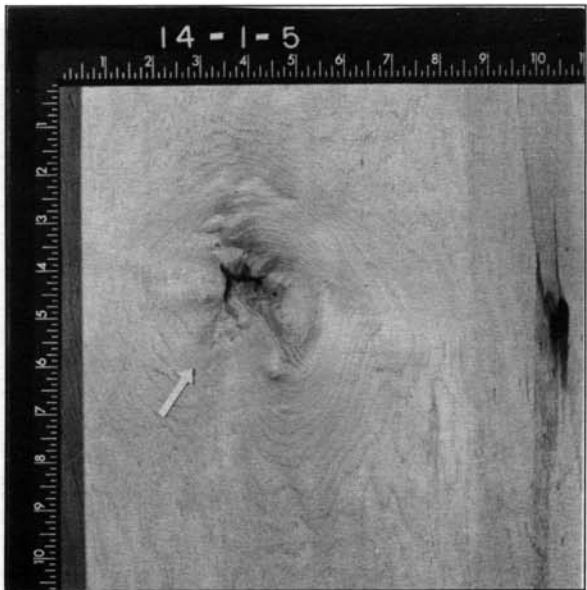
Figure 13.—Surface rise and associated internal defects.

A surface rise is the lowest category (least damaging) of bumps (Rast et al. 1973). It is not considered a degrader since the defect beneath it is deep enough to be disregarded in log and tree grading. The surface rise shown in Figure 13 meets both criteria for not being considered a defect—the ratio of height to length is less than 1:12 and the defect is

contained within the inner quality zone and the heart center. More than 90 percent of all bumps (regardless of the category) are caused by overgrown knots or suppressed bud clusters. The underlying defect in Figure 13 is a suppressed bud cluster.

Defect size 4 × 8 × 0.1 inches
 Log diameter at defect (ib) 13.0 inches
 Round-up thickness 0.1 inch
 Core diameter 5.8 inches
 Defect distance above stump 8.5 feet

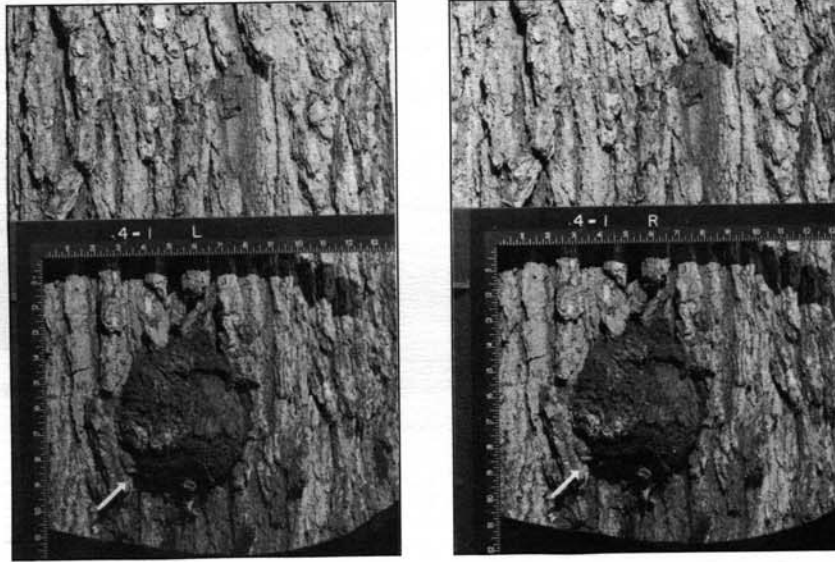
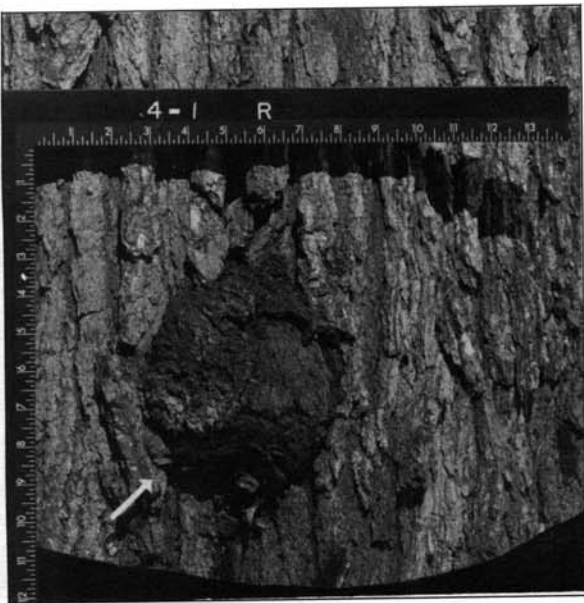
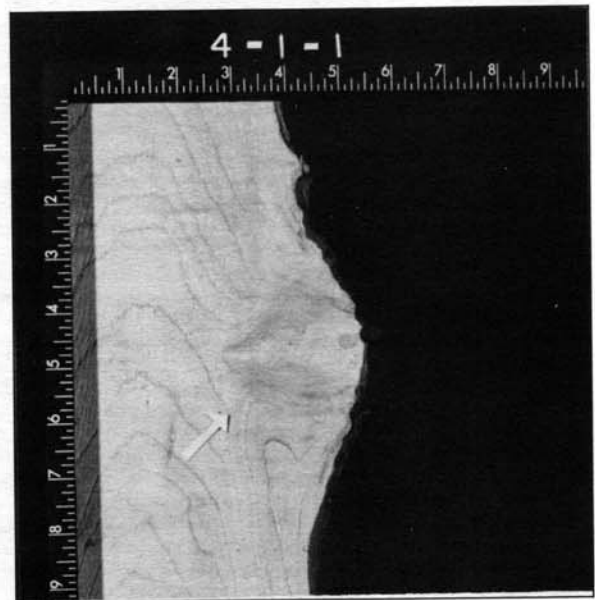
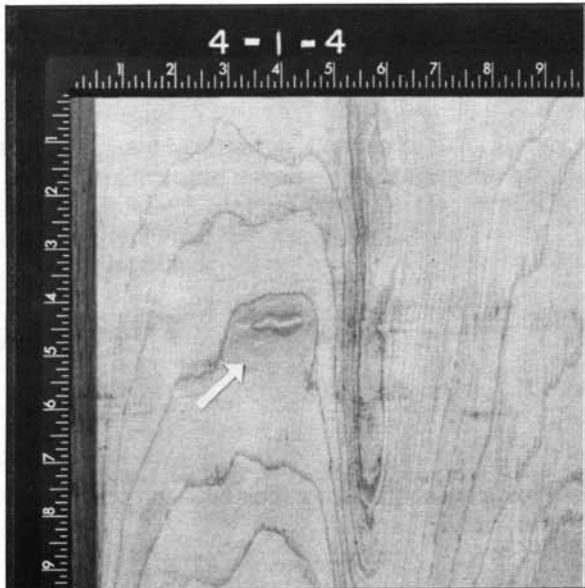
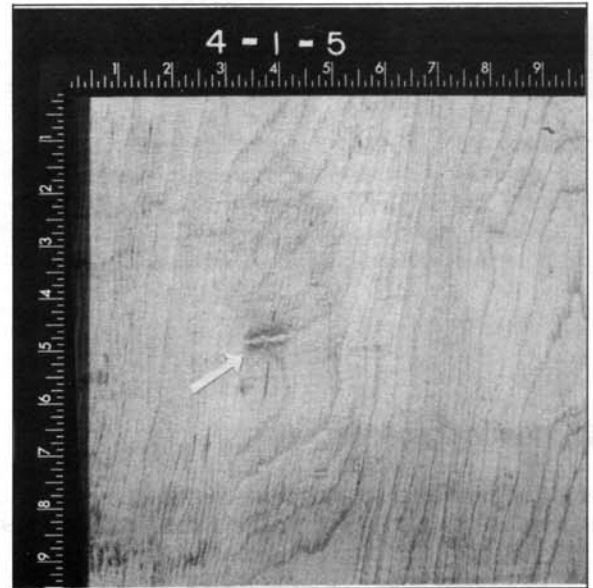
Figure 14.—Burl and associated internal defects.

Burls are accompanied by distorted grain, and often they contain ingrown bark, rot, stain, and occasionally epicormic knots. Burls are definitely a defect, but there is a specialty market for large burls for the production of such items as bowls and other novelties. Figure 14 shows a burl on sugar

maple that contains some stain and rot, but other than that, there is just a small area of distorted grain going all the way back to the heart center. Most burls are usually very low to the ground and often a high stump is cut to eliminate it from the sawlog. This burl was only 1.5 feet above the stump.

Defect size	5 x 5 x 3 inches
Log diameter at defect (ib)	19.9 inches
Round-up thickness	0.0 inch
Core diameter	7.8 inches
Defect distance above stump	1.5 feet
