Research Paper NE-647

Photographic Guide of Selected External Defect Indicators and Associated Internal Defects in Sugar Maple

Everette D. Rast
John A. Beaton
David L. Sonderman

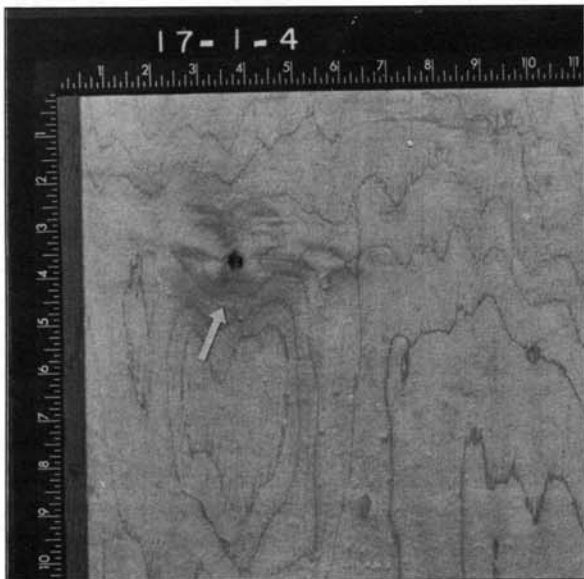
Log surface 2.5 inches
First sheet of veneer 2.0 inches

Epicormic branches develop from two types of buds: suppressed or dormant buds and adventitious buds (Kormanik and Brown 1969 and Shigo 1986). **Suppressed buds** (Figs. 1 and 2) can persist for many years as a bud trace or they can sprout suddenly after some stimulus such as thinning or damage to the tree. After sprouting, many develop into small limbs that often die. In contrast, bud traces usually continue to form in the cambial zone even after the epicormic limb dies and eventually drops off (Fig. 1), sometimes forming another epicormic limb which may or may not develop. Occasionally the suppressed bud may cease all activity in the cambial zone following its occurrence, showing no evidence of the bud trace (Fig. 2). By contrast, adventitious buds form anew from the cambium, usually following injury to the tree. The defect indicator for both bud types is identified by a slight break in the bark pattern with a small protuberance in the center.

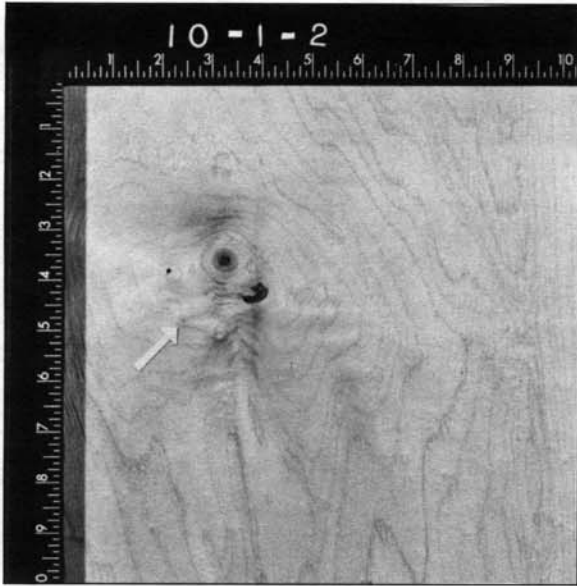
Log surface 2.0 inches
 First sheet of veneer 2.0 inches

Figure 3 shows a faint evidence of the concentric rings around the defect indicator and the presence of several individual buds. Also, several adventitious knots are visible in the defect photos.

Figure 3.—Suppressed bud cluster and associated internal defects.

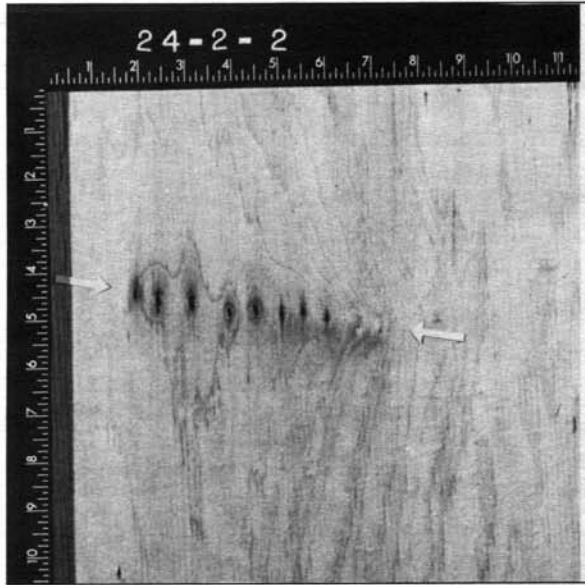
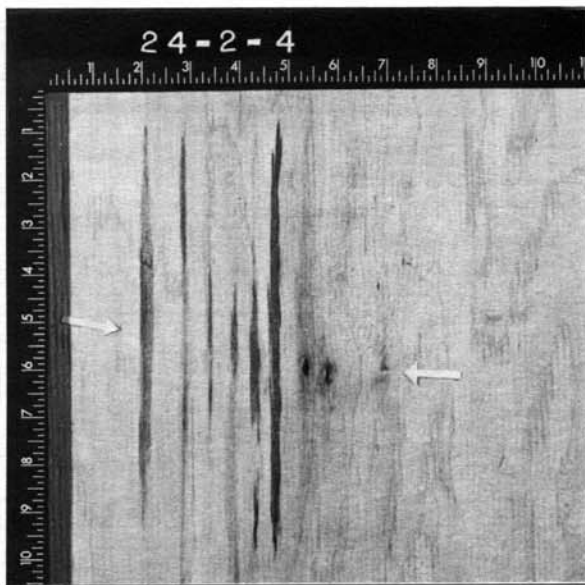
By contrast, in looking at the **occluded bird peck** in Figure 5, one can observe clearly the callus material in the pecked holes and the defects in the underlying wood. The accompanying stain is quite normal with occluded bird peck due to the easy entry of moisture and pathogens. Severe bird peck can lead to a separation of the wood along the rings.

Figure 5.—Occluded (closed) bird peck and associated internal defects.

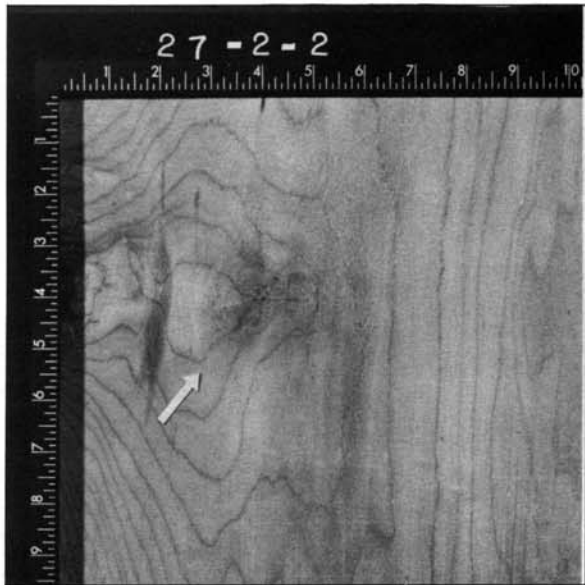
Log surface 4.5 inches
 First sheet of veneer 4.5 inches

Bark distortions usually indicate an overgrown knot, and because of age they have no height measurement (flush with the normal contour of the bark). They are classified as light, medium, or heavy. A **light bark distortion** (Fig. 6)

shows a slight amount of curvature in the surrounding bark plates, and the bark pattern varies only slightly from normal. Because of these features, light bark distortions are inconspicuous and often overlooked. **Medium bark distortions** (Fig. 7) show more of the concentric circles, but they are broken in several areas by flat bark plates or the

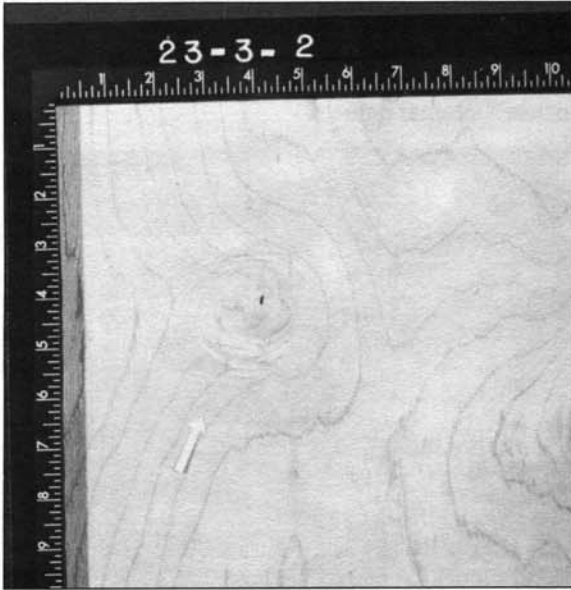
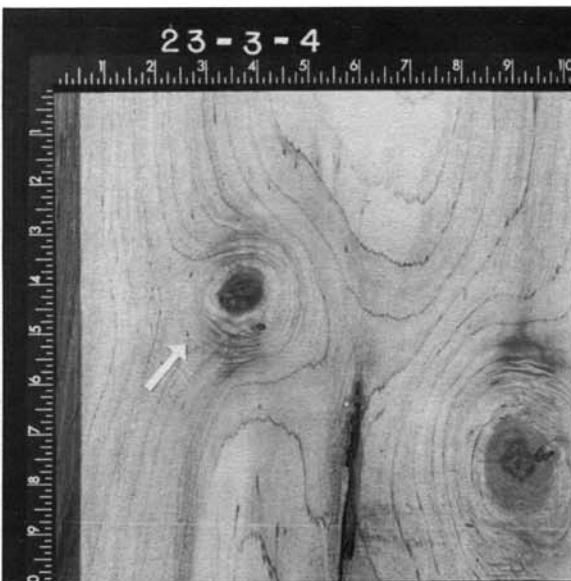
Figure 7.—Medium bark distortion and associated internal defects.

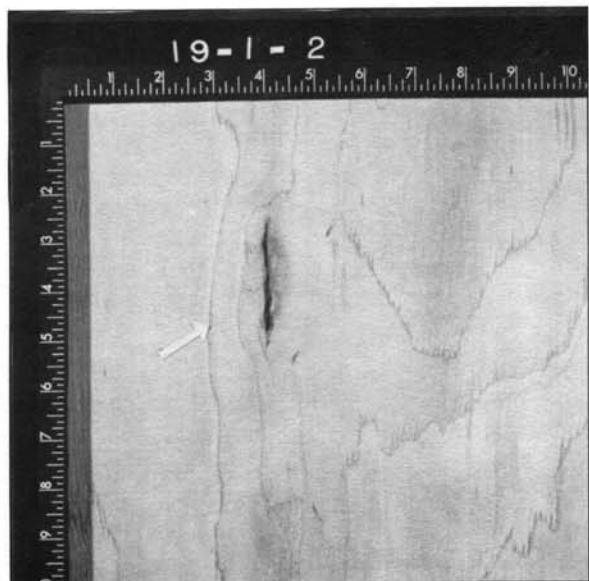
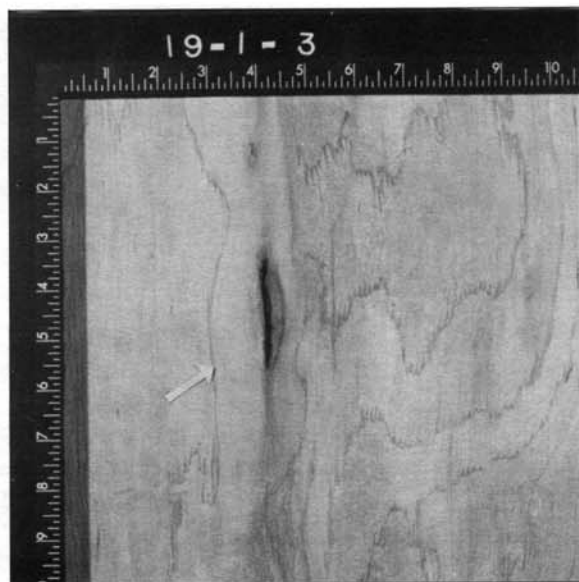
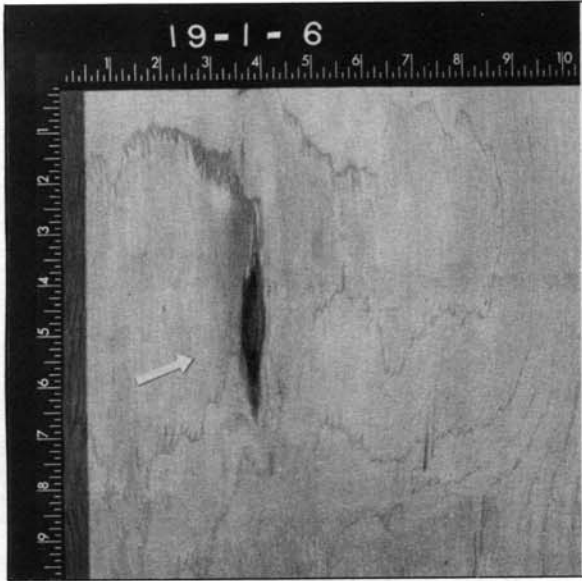
The defect in Figure 9, a **sound wound (new)**, probably was a clean, smooth removal of the bark and some wood on a fast-growing tree because the first and last evidence of the defect in the veneer is contained within eight-tenths of an inch. Figure 10 shows a **sound wound (old)**. The primary difference between these wounds is that the callus tissue surrounding the “new” wound is rough or corky, can have many lines perpendicular to the long axis, and has only a slight ridge or pucker surrounding the seam running lengthwise through the defect indicator. Even the lengthwise seam may be visible only in certain areas. The bark plates surrounding the defect indicator usually are rough and jagged. By contrast, the callus tissue of the “old” wound has a “washed out” or more natural bark appearance, a smooth or nearly smooth surface, and more of a bark-like fissure running lengthwise through its center. The bark plates surrounding the defect indicator of the old

Figure 10.—Sound wound (old) and associated internal defects.

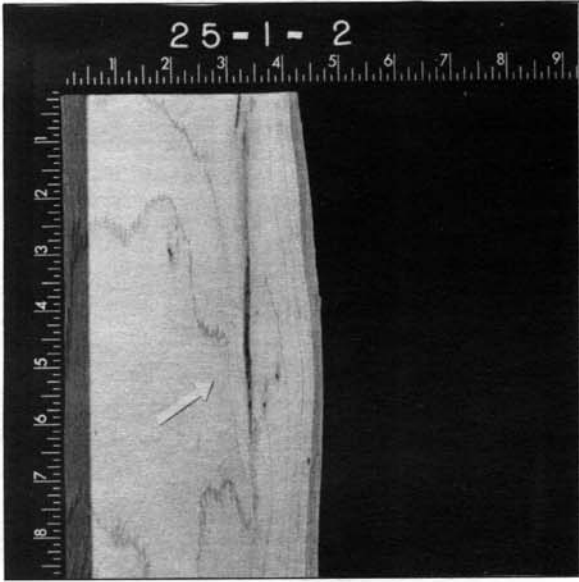
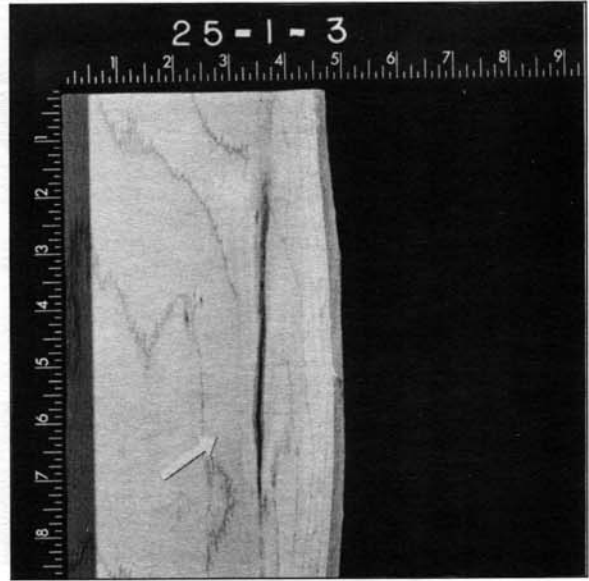
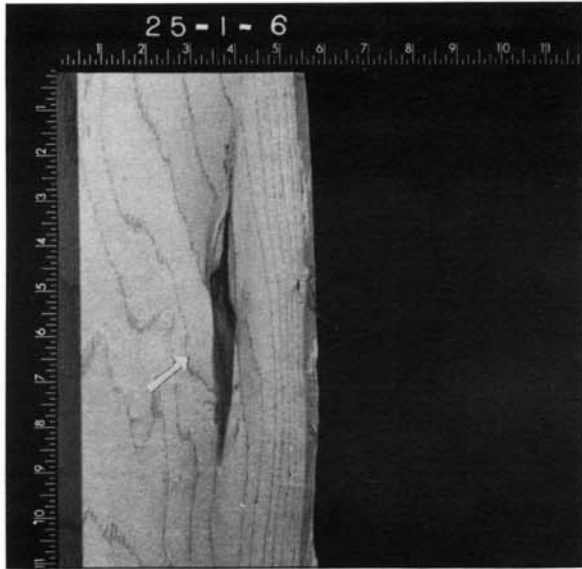
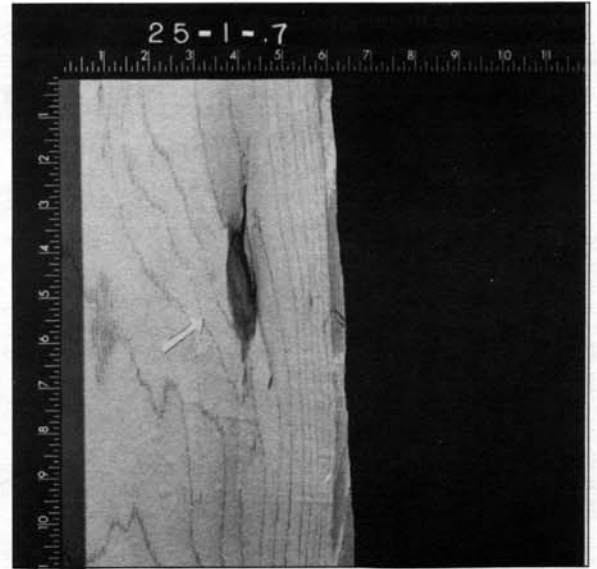
An uncommon wound encountered during this study is that caused by the felling of one tree against another during the period of active cambial growth (W.C. Shortle, USDA Forest Service, pers. comm. 1989). Trees are most susceptible to wounding from an object hitting the bark in early spring. The damage we noted ranged from 3 or 4 wounds to 25 wounds per tree, and these always were on only one side of the tree stem. They ranged in height from 5 to 40 feet above the ground and ranged in length from 3 to 12 inches. Figures 11 and 12 are typical examples of these defects. The first evidence of each of these defects was about one-half inch below the surface of the log and the last evidence of the defect in the wood generally was 1 inch below the surface of the log. Personnel with the Florence Ranger District confirmed that the felling in this area took place in 1984 during the last week of March and the first couple of weeks of April. The growth rate of the sample trees averaged about one-quarter inch per year and the study trees were cut in September 1987, which correlates with the fact that the deepest defects are approximately 1 inch below the surface of the log. Defects of this nature will be devastating to the quality of those trees affected, particularly during a selection cutting in which the remaining trees are in the intermediate and mature sawtimber size classes.

Figure 11.—Sound wound and associated internal defects. (Early spring felling damage)

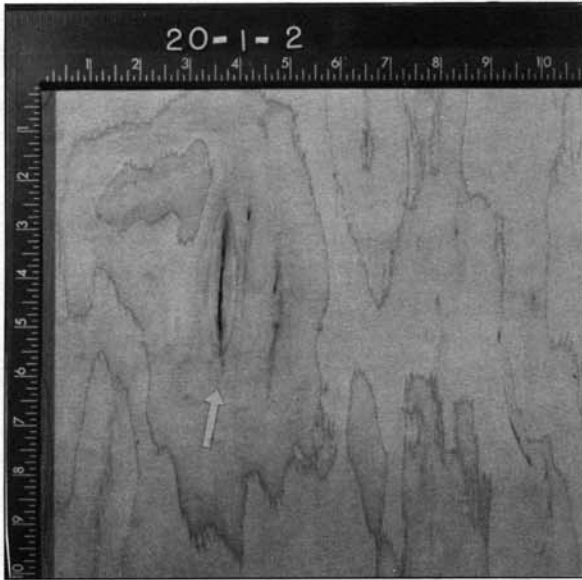
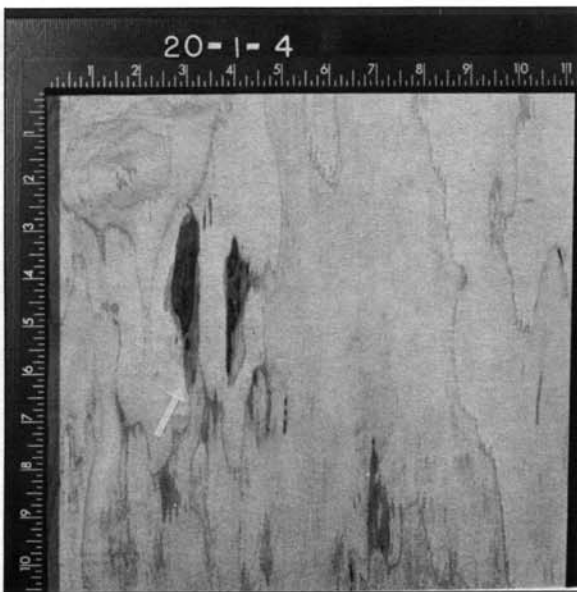
Figure 12.—Sound wound and associated internal defects. (Early spring felling damage)

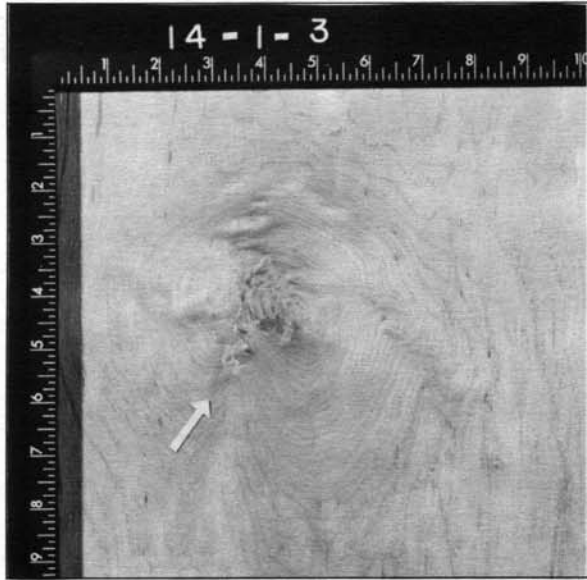
Log surface 3.1 inches
 First sheet of veneer 3.0 inches

A surface rise is the lowest category (least damaging) of bumps (Rast et al. 1973). It is not considered a degrader since the defect beneath it is deep enough to be disregarded in log and tree grading. The surface rise shown in Figure 13 meets both criteria for not being considered a defect—the ratio of height to length is less than 1:12 and the defect is

contained within the inner quality zone and the heart center. More than 90 percent of all bumps (regardless of the category) are caused by overgrown knots or suppressed bud clusters. The underlying defect in Figure 13 is a suppressed bud cluster.

Figure 13.—Surface rise and associated internal defects.

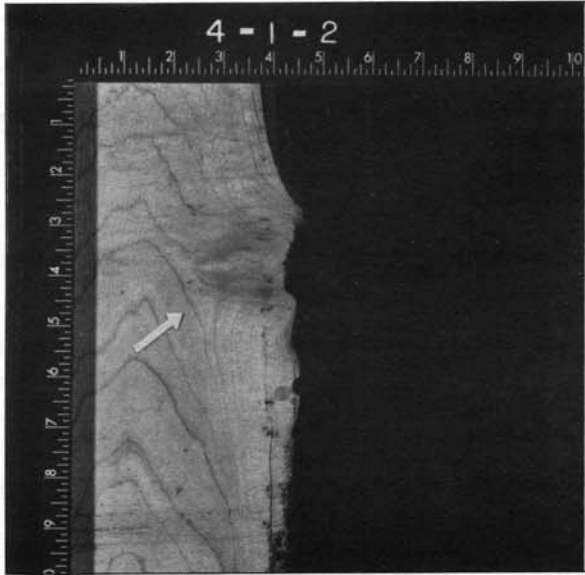
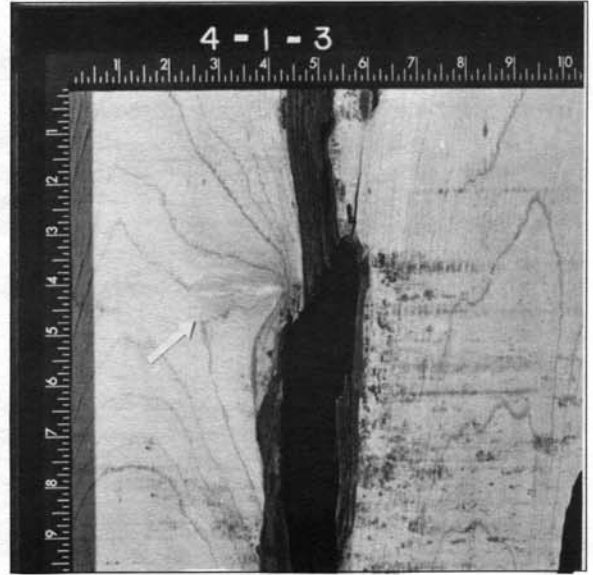
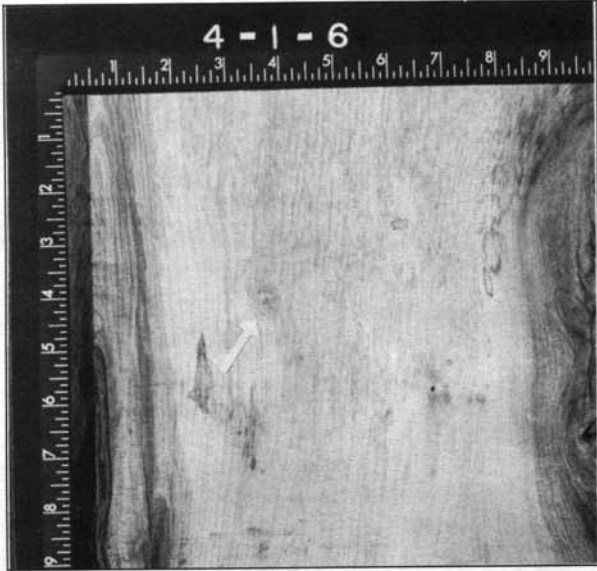
Burls are accompanied by distorted grain, and often they contain ingrown bark, rot, stain, and occasionally epicormic knots. Burls are definitely a defect, but there is a specialty market for large burls for the production of such items as bowls and other novelties. Figure 14 shows a burl on sugar

Figure 14.—Burl and associated internal defects.
